Via Email: *MMueller@smithmgmt.com*
Property: **Appletree Condominiums**
1139 Appleseed Ln, Olivette, 63132

Service: **FULL RESERVE STUDY**

Project No.: 202212-10

Appletree Condominium Association Reserve Study

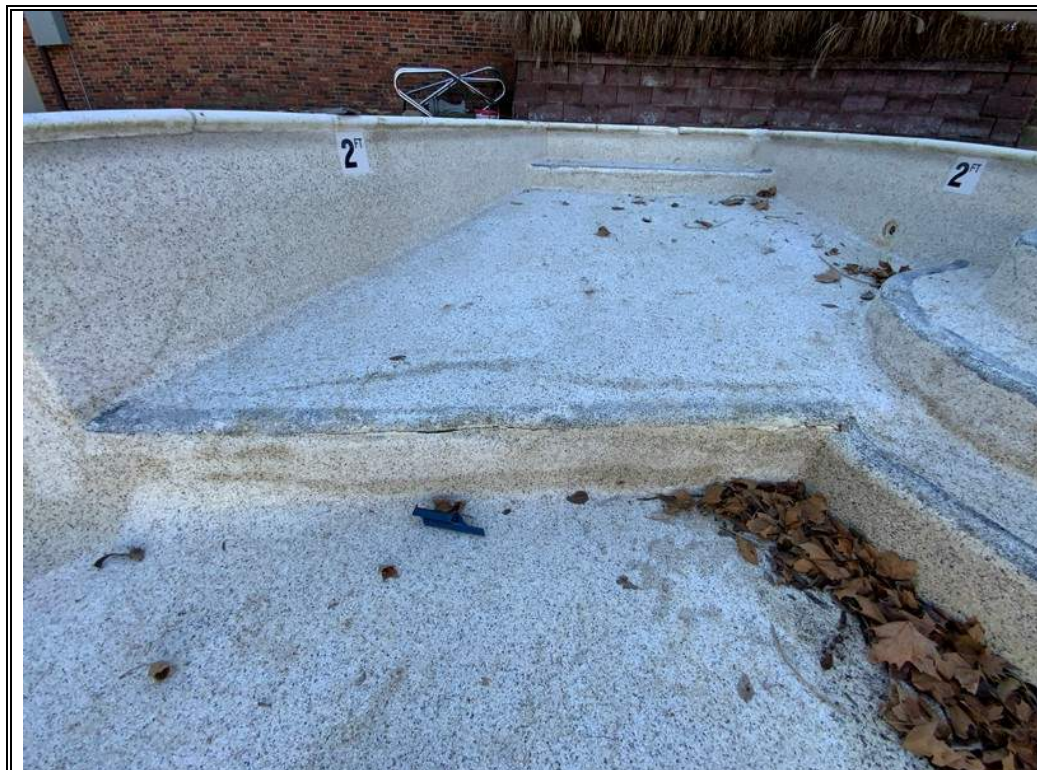
Pool: The Association is responsible for maintaining an outdoor pool located at the northeast corner of the property. The pool has tile coping with Pebble Tec surfaces. It was unknown when the pool was last resurfaced. The pool was drained at the time of our visit and we observed limited cracking and general deterioration of the pool surfaces. Typically at the time of resurfacing, pools should be drained, minor cracks repaired, and surfaces recoated. We have budgeted funds for full resurfacing and repairs of the pool on a 15-year cycle beginning in 2026.

Pool surfacing

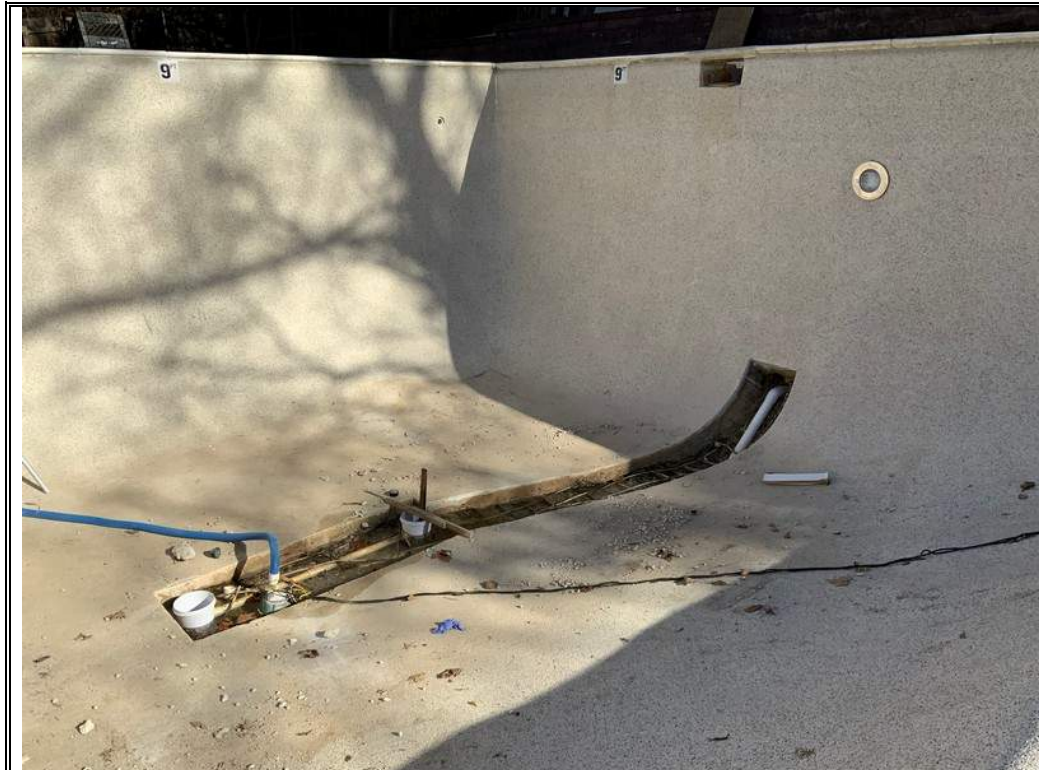
Pool Cover: The pool was uncovered at the time of our visit for minor plumbing repairs and pool deck replacement. We did not observe the pool cover. It is our understanding that the pool cover is a custom reinforced vinyl pool cover. We have allocated funding to replace the pool cover on an 8-year cycle beginning in 2028.

Pool plumbing
repairs

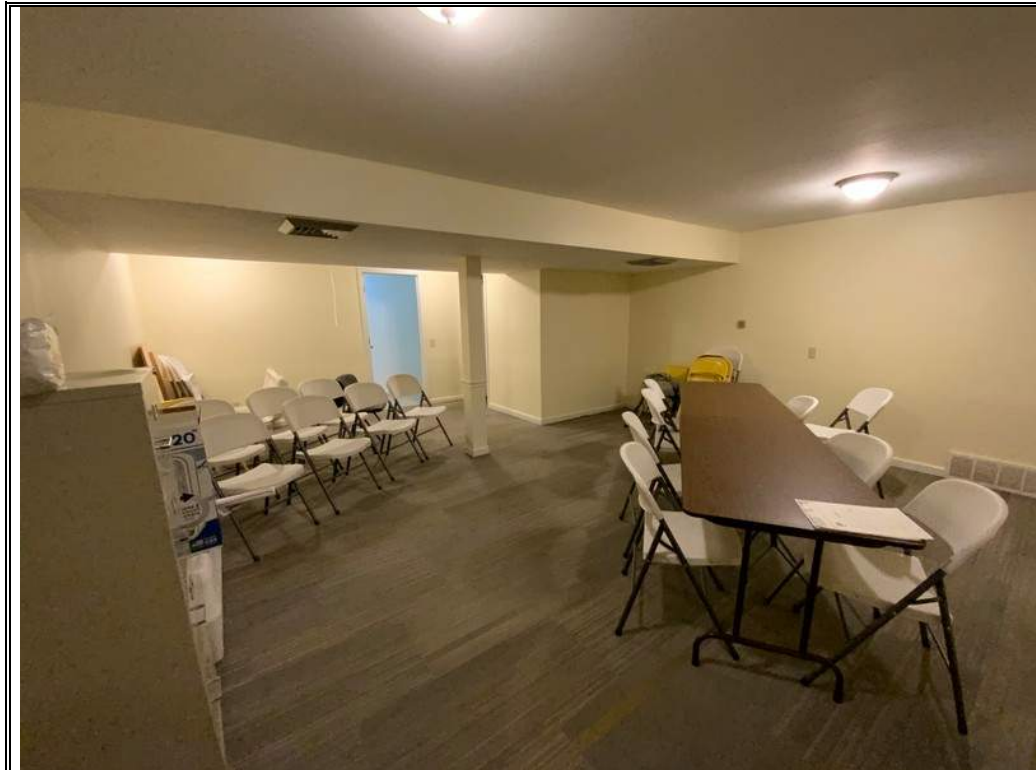
Photo Number

Club Room: A common community club room includes tables, chairs, and a restroom. Floors are carpeted and walls and ceiling are painted drywall. The clubroom was observed to be in generally fair condition, yet dated. We have allocated funding to refurbish/update the clubroom every 30-years beginning in 2028.

Interior of the
Club Room

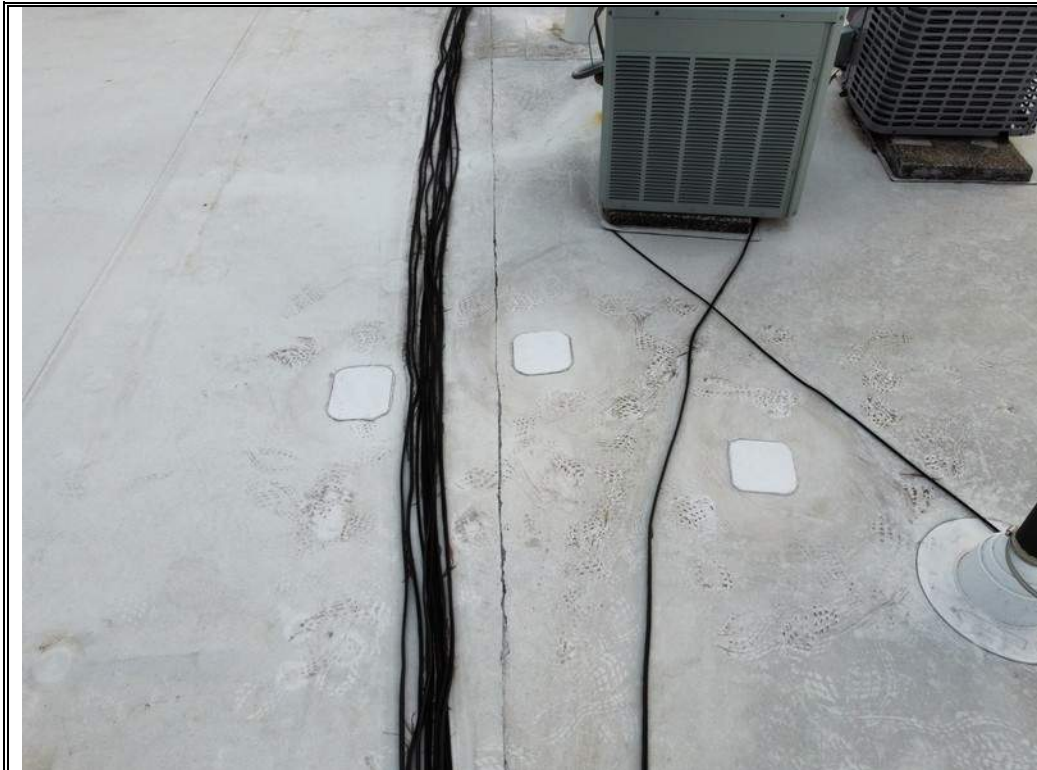
The top of the condominium buildings are surfaced with TPO membrane. It was reported that the roofs were last replaced approximately 10 years ago. We noted limited wrinkling and evidence of standing water on the membrane surfaces. No reports of water intrusion were reported at the time of our visit. This type of roofing has an expected useful life of approximately 20 years. We strongly recommend that any re-roofing project closely follow procedures outlined by the National Roofing Contractors Association's Roofing and Waterproofing Manual. A re-roofing sequence should include removal of the existing roofing material, replacement of any inadequate roof sheathing, replacement of any damaged flashing, and replacement of drip edge components. Based on the current age and condition of the roofs, we have allocated funding for replacement of the roof membranes and gutters on a 20-year cycle, beginning in 2034.

Patching in the
TPO membrane

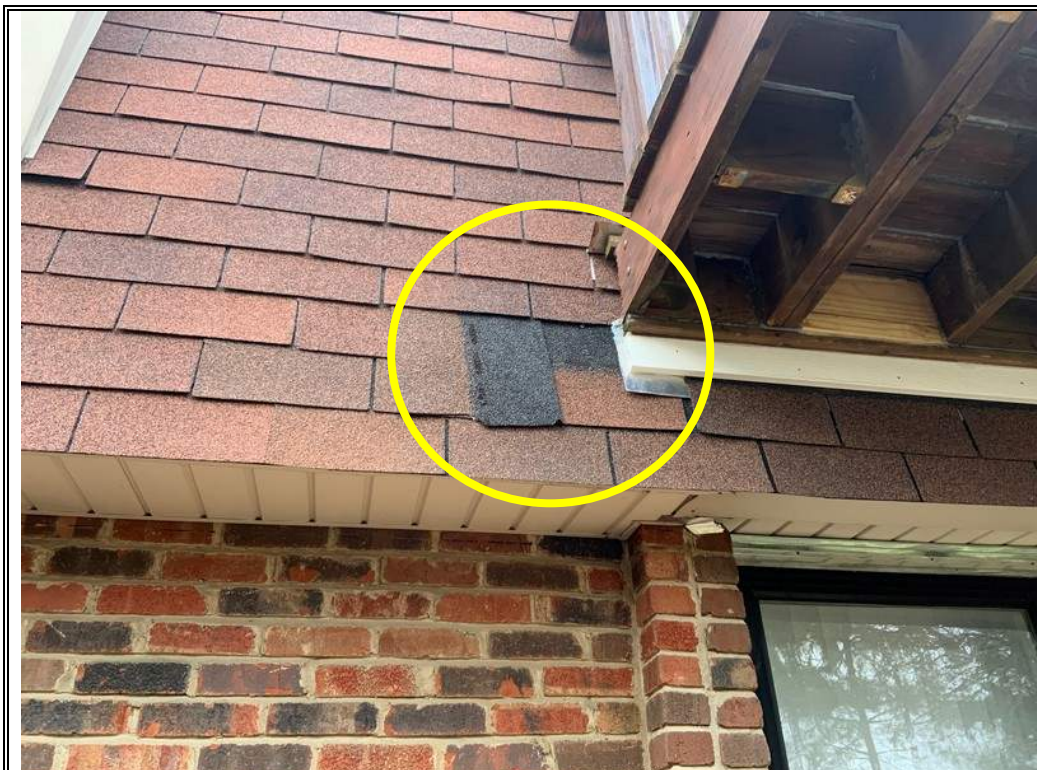
Roofs and Gutters: The pitched Mansard style roof surfaces over the condominium buildings are covered in asphaltic fiberglass shingles with thermoplastic polyolefin (TPO) on top of the buildings. The 7 carports are surfaced in asphaltic fiberglass shingles as well. The Mansard roofs and carport roofs throughout the community appear to be reaching the end of their useful lives. We noted multiple missing or damaged shingles on the buildings. Staining, shingle curling, and granular loss was observed throughout. It was unknown when the asphalt roofs on the condominium buildings and car ports were last replaced. We have allocated funding to replace the Mansard roofs on the condominium buildings and the asphalt shingles on the carports on a 20-year cycle beginning in 2025.

Damaged shingles

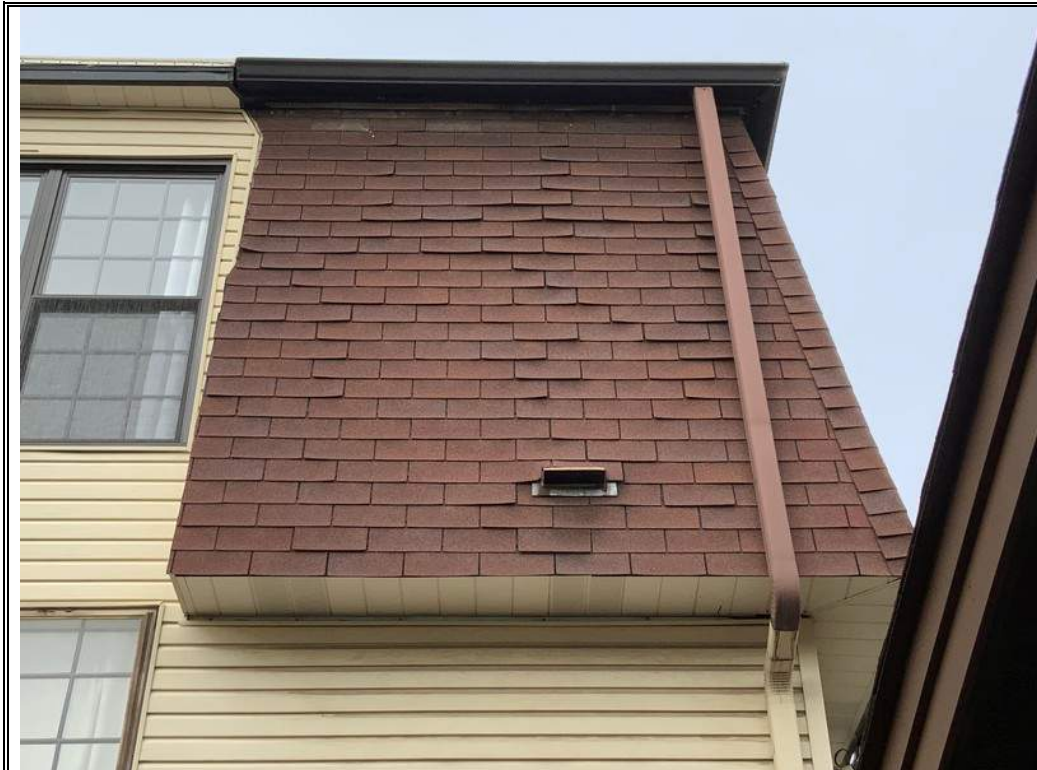
Curled shingles

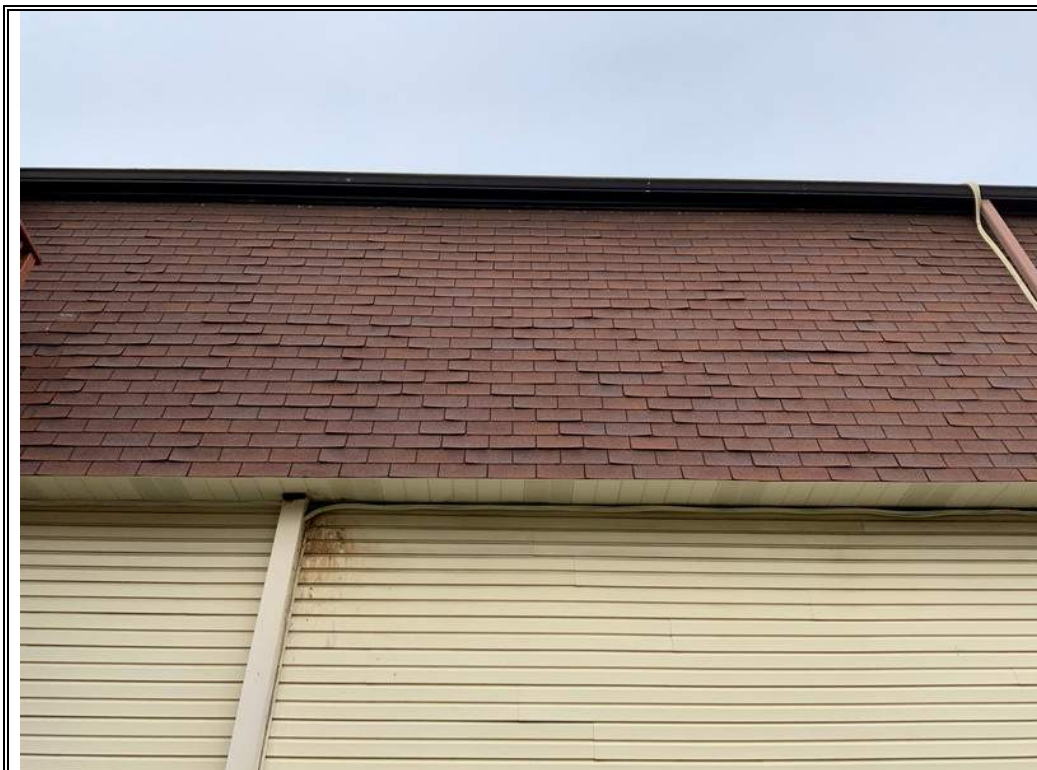
Curled shingles

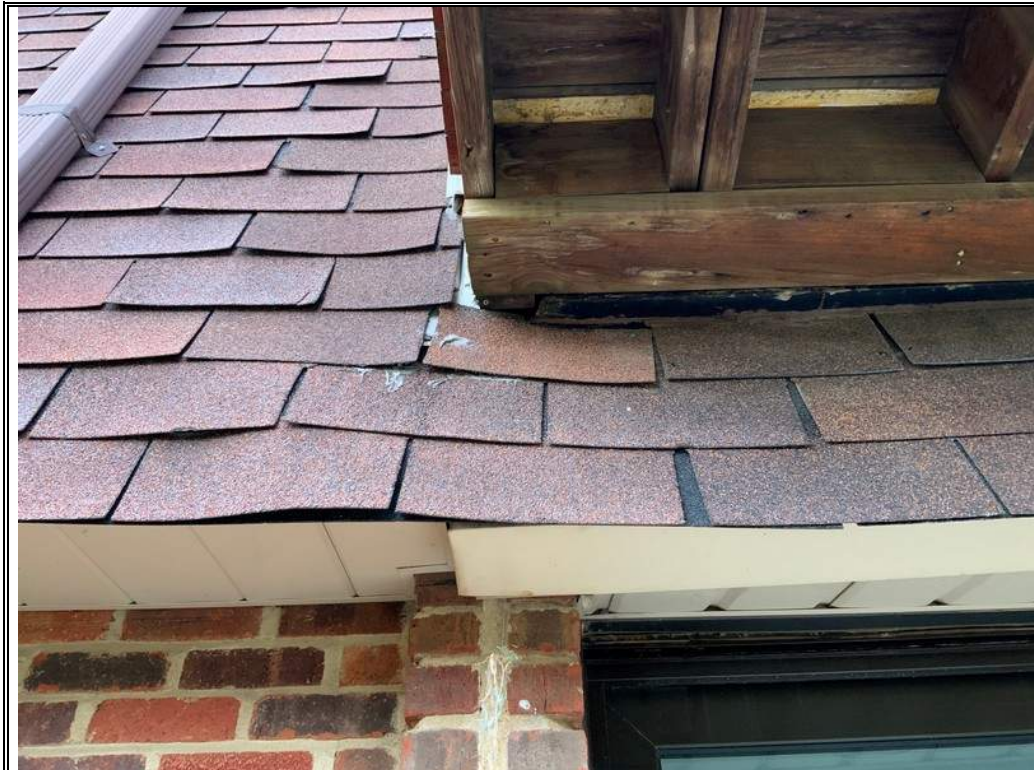
Damaged shingles

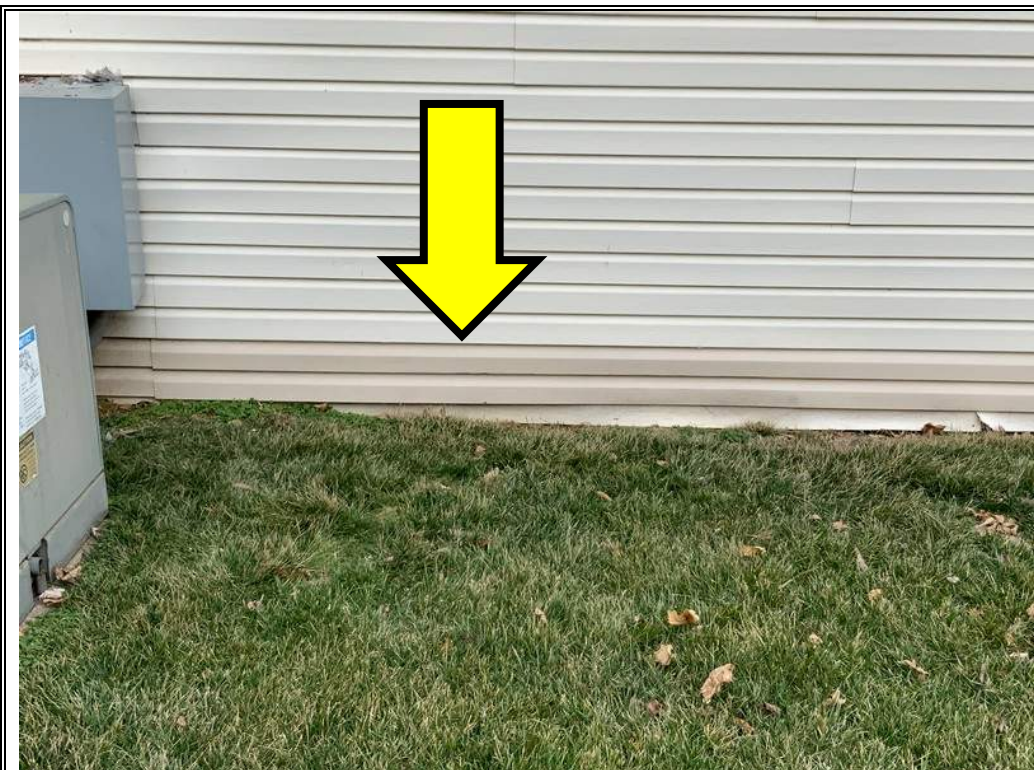
Vinyl Siding: The rear elevations of the condominium buildings are clad in vinyl siding. It was reported that the vinyl siding on the buildings was last replaced in 1997 and was observed to be in generally good condition. Assuming repairs are completed in the interim, this type of siding has an expected useful life of approximately 40 years. We have allocated funding to replace the vinyl siding on the condominium buildings in two phases beginning in 2037.

Vinyl siding that
has been replaced
due to damage

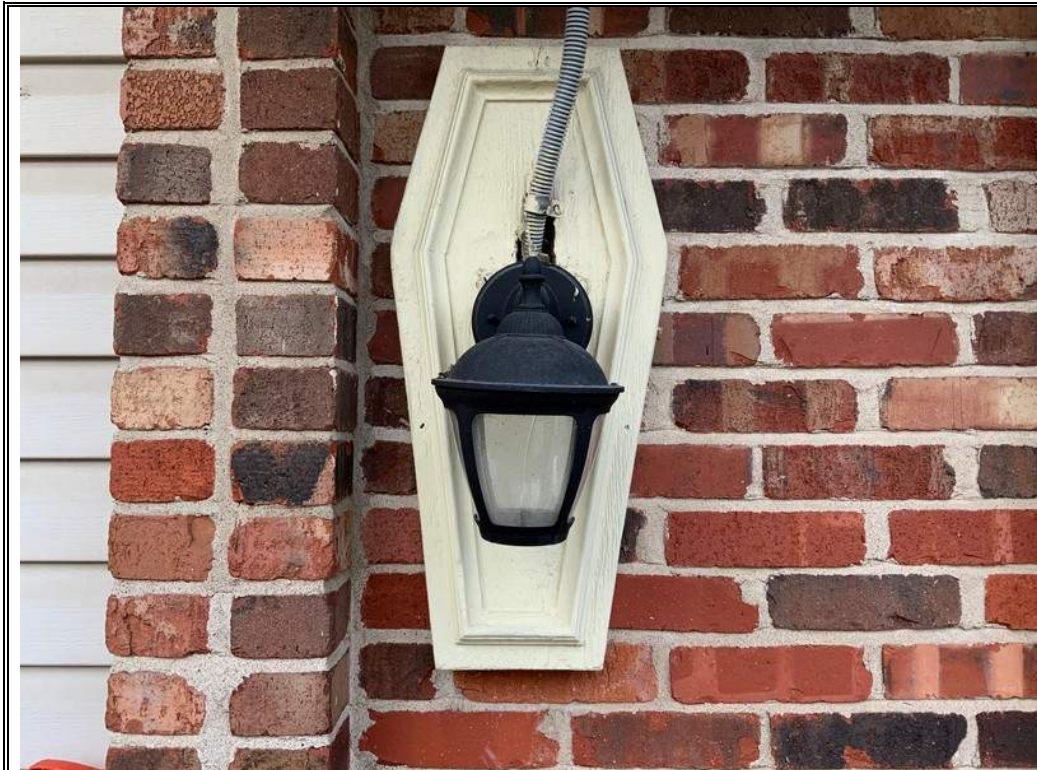
Exterior Light Fixtures: Wall mounted exterior light fixtures are located at the main entrances to the condominium buildings. The light fixtures were observed to be in fair condition and likely reaching the end of their useful lives. Exterior light fixtures of this age typically have a useful life of 25 years. In order to maintain aesthetic uniformity, we have allocated funding to replace all of the building entrance fixtures on a 25-year cycle beginning in 2028.

Typical exterior
mounted light
fixture

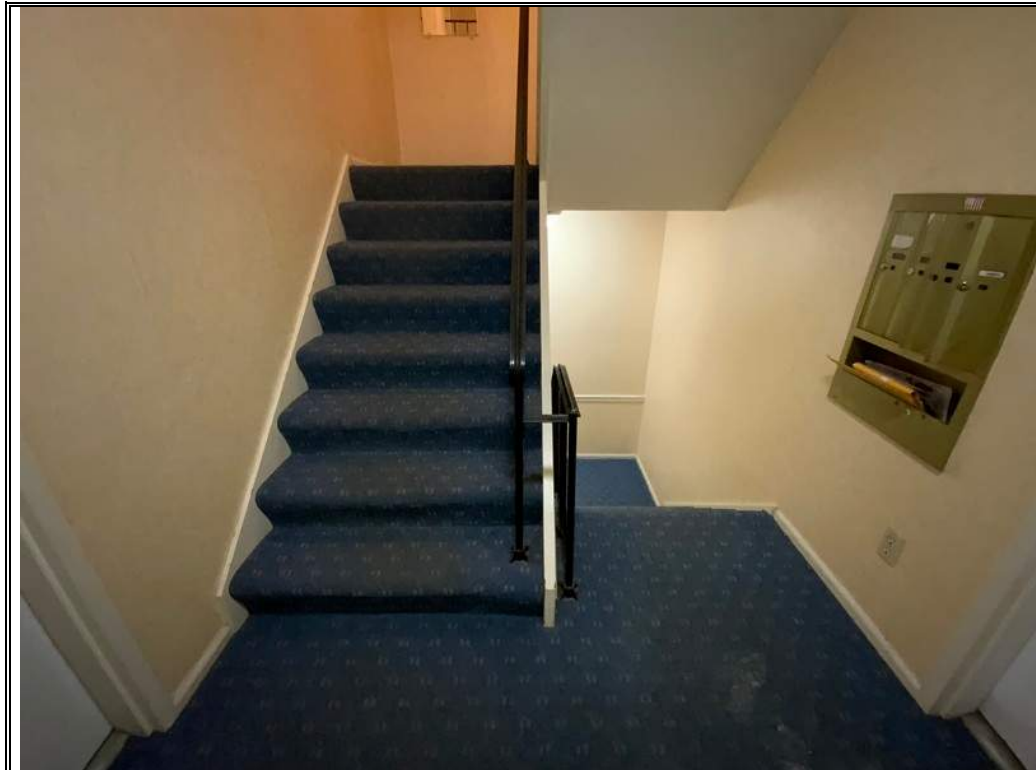
Paint: The interior corridor walls and ceilings are painted or wallpapered drywall. Stairs and landings are carpeted. The interior walls and ceilings were in fair to poor condition with nicks, staining, and peeling wallpaper observed. It was reported at the time of our visit that the Association is planning to remove all wallpaper and paint the interior surfaces of the common corridors in the near-term. We have allocated funding to paint the interior corridors on a 12-year cycle beginning in 2024.

Typical interior
stairwell

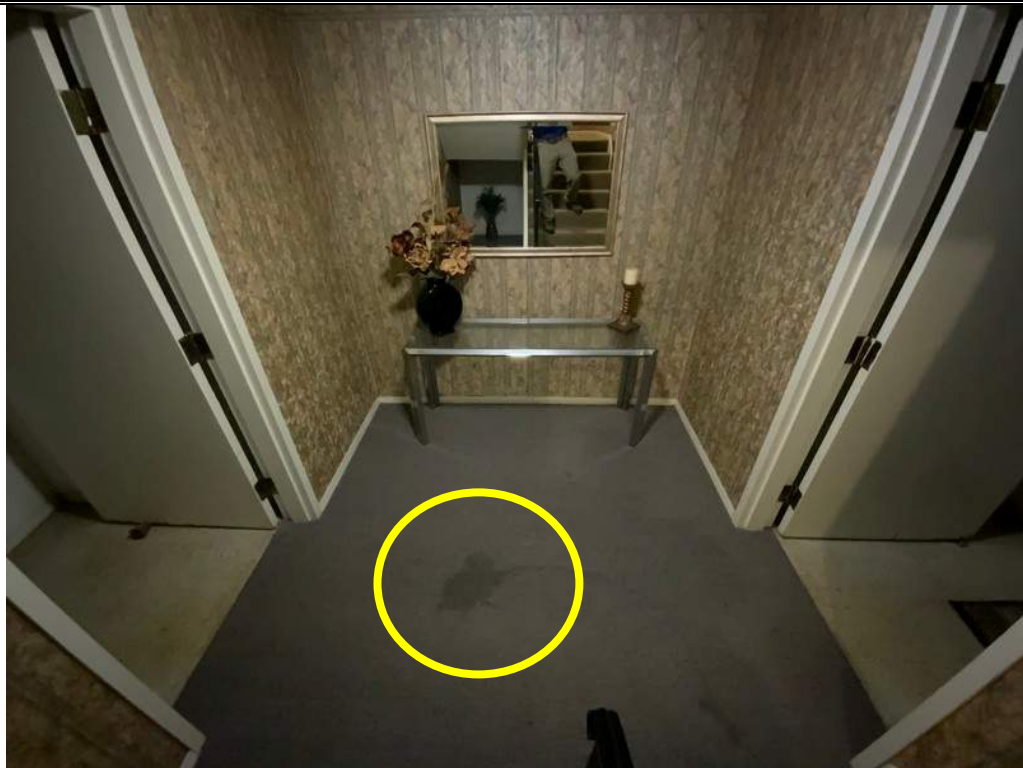
Carpets: The interior stairwells and landings are carpeted. The carpeting was observed be in generally fair to locally

poor condition. We have allocated funding to replace the interior carpets on a 12-year cycle beginning in 2024.

Carpet staining

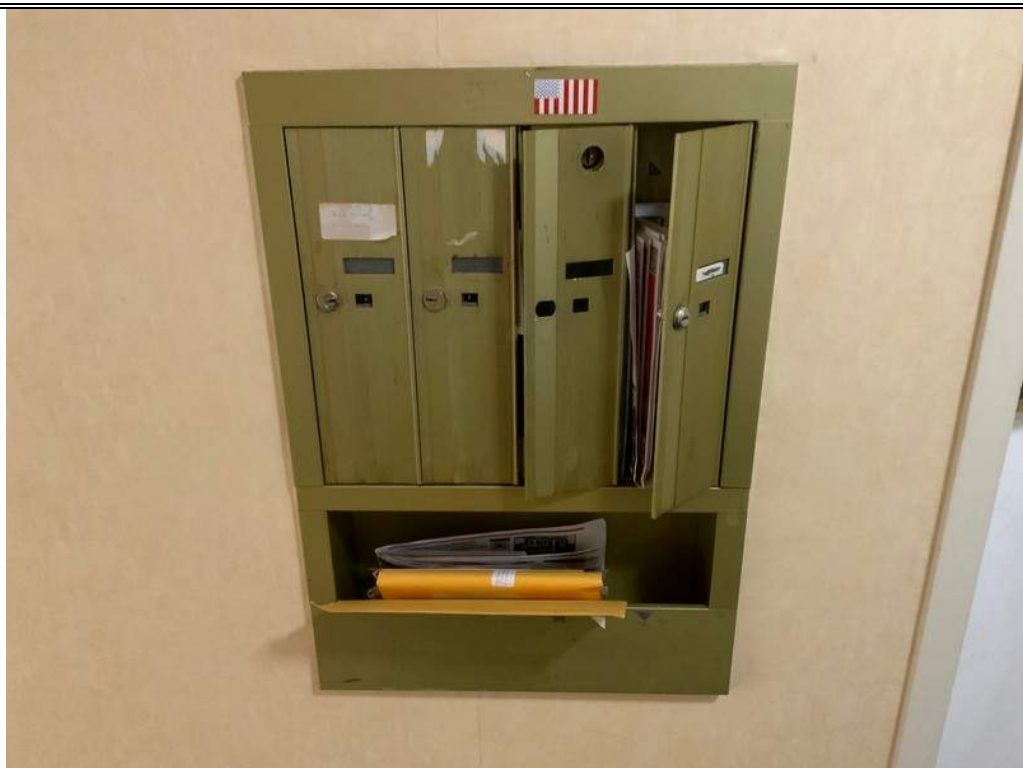
Mailbox Inserts: The entry vestibules include metal mailbox inserts. The mailbox inserts were observed to be in fair condition and are likely original. We have allocated funding to replace the mailbox inserts on a 40-year cycle beginning in 2030.

Typical mailbox
insert

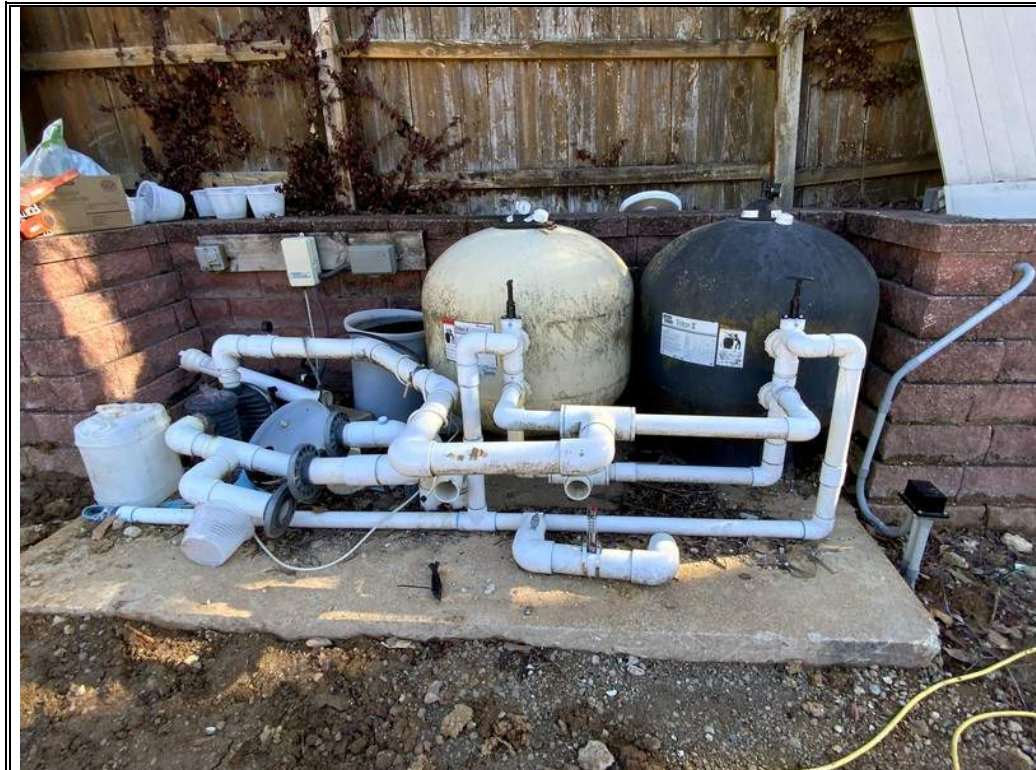
Pool Pumps and Filters: The property includes a centrally located in-ground pool. The pool is serviced by a 1 and 2 HP pump and two sand filters. It appeared that the pool mechanical equipment was functioning adequately, and no issues were reported. The age of the pool mechanical systems is unknown. These pump and filtration systems have an expected useful life of 10-15 years and are typically replaced as they fail. We have allocated funds to replace the pumps and filters on a 12-year cycle, beginning in 2025.

Pool pumps and
filters

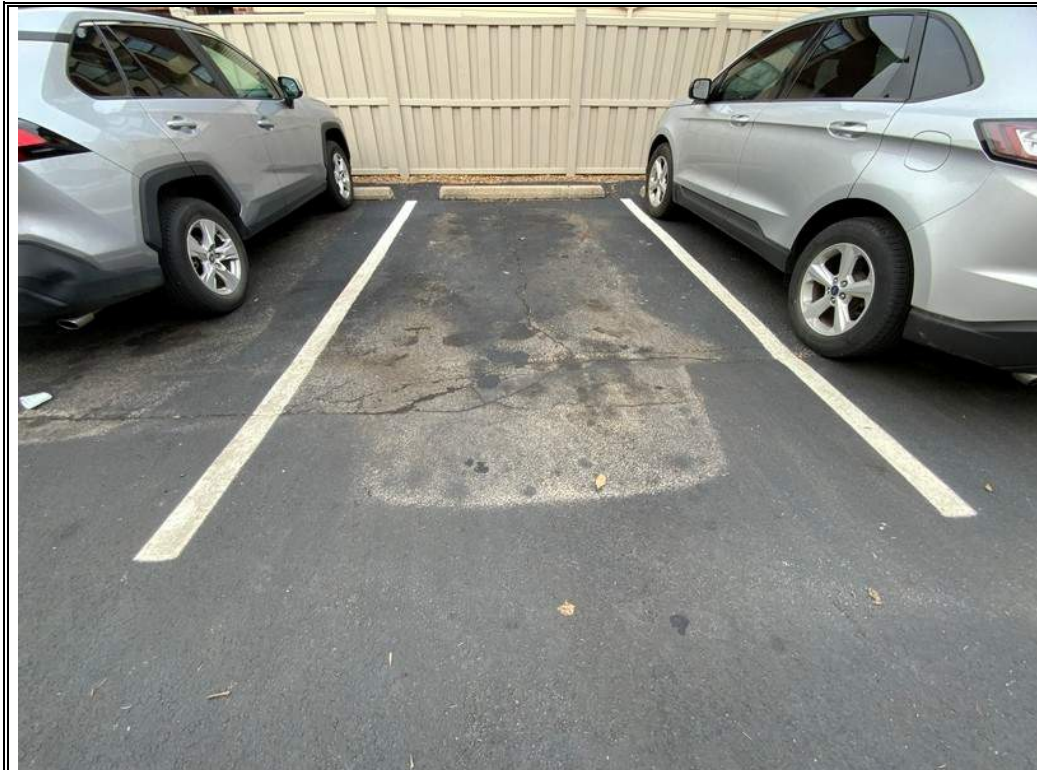
Partially sealed
parking space

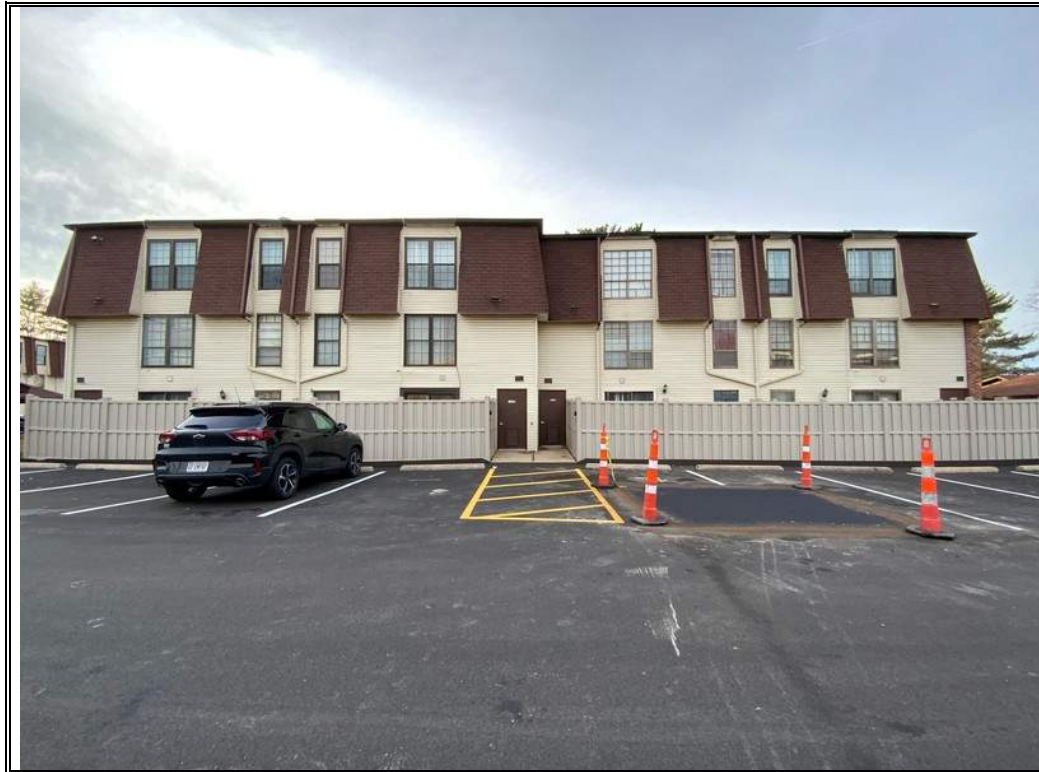
Asphalt Streets and Parking Areas: The asphalt streets and parking areas throughout the community are privately maintained by the Association. The asphalt surfaces are generally in good condition, with the exception of under the carports. In some areas, we noted limited areas of localized fatigue cracking, which will need eventual repair. Localized areas of poor asphalt are evidenced by significant fatigue cracking, rutting, and potholes. Areas of fatigue cracking, upheaval and pot holes will require full depth reclamation to repair. This would include saw cutting and removing sections of paving, repairing base course/sub-grade as needed and installing new 2" to 4" thick asphalt paving. We have allocated funds for full depth repairs of approximately 5% of the asphalt surfaces on a 5-year cycle beginning in 2027.

Sectional repair in
the asphalt parking
lot

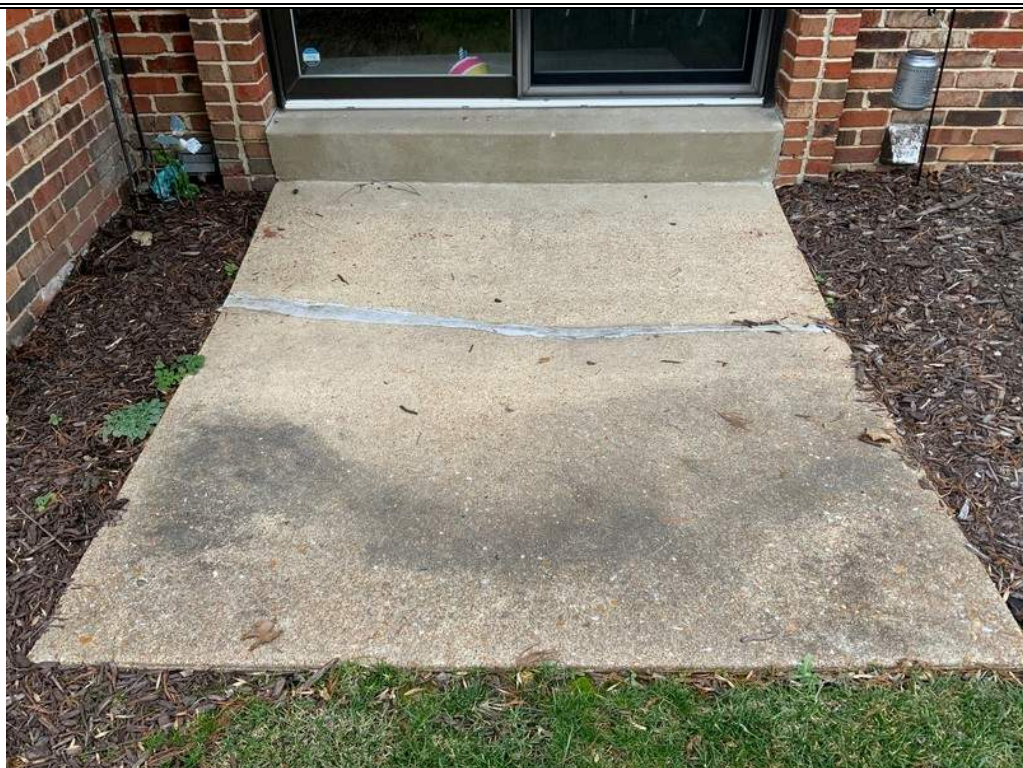
41

Sealed crack from
concrete settling

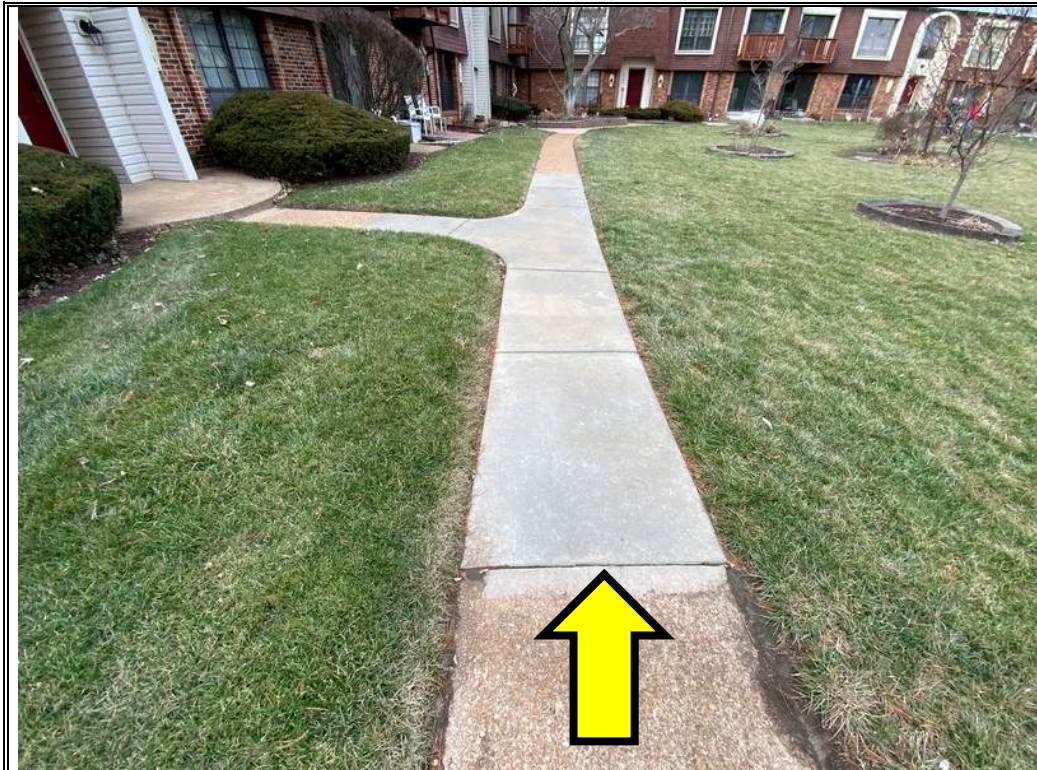
Previous sectional
repairs in the
concrete sidewalks

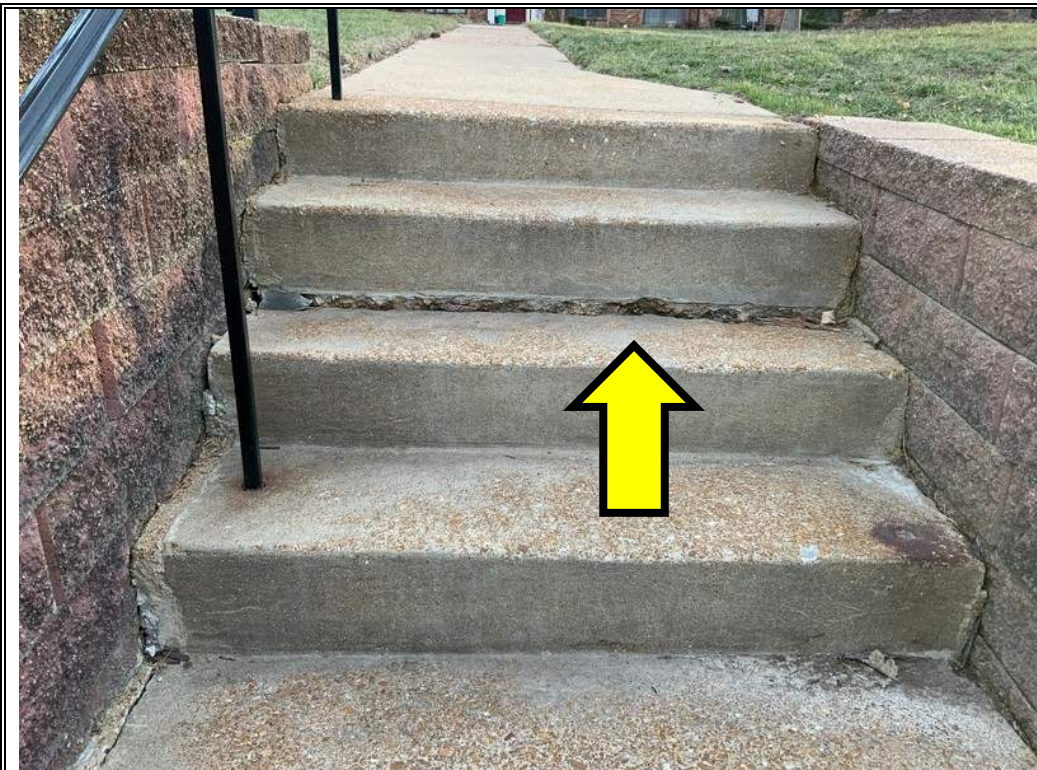
Settled and
cracked concrete
stairs

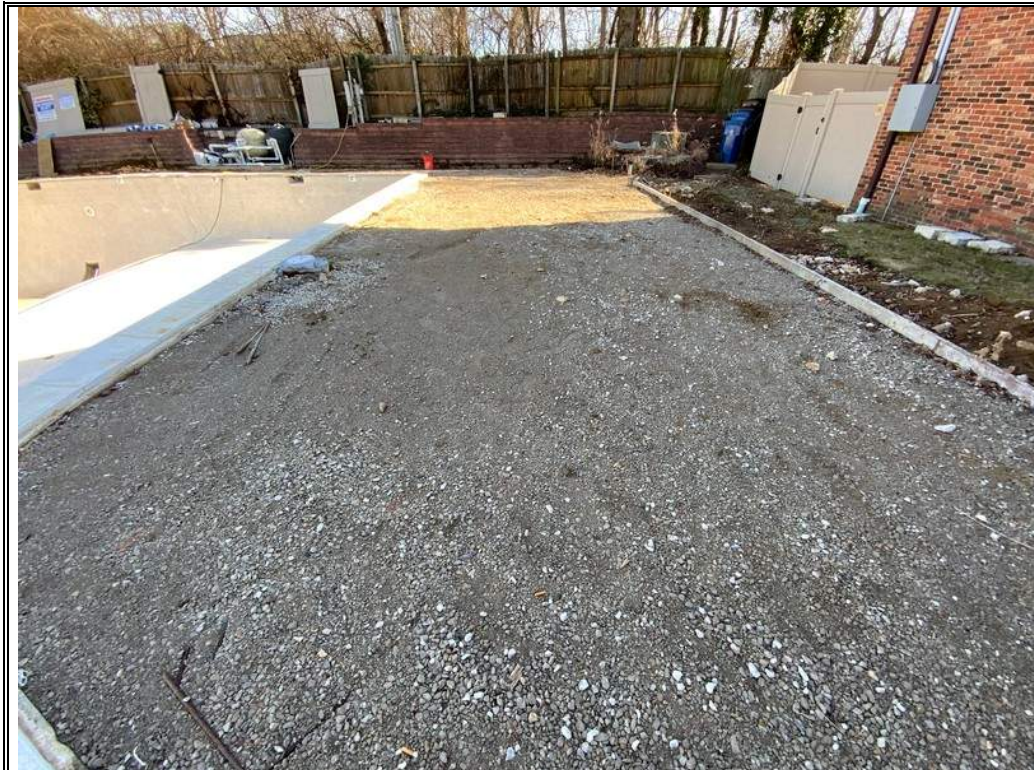
The pool deck is
being replaced

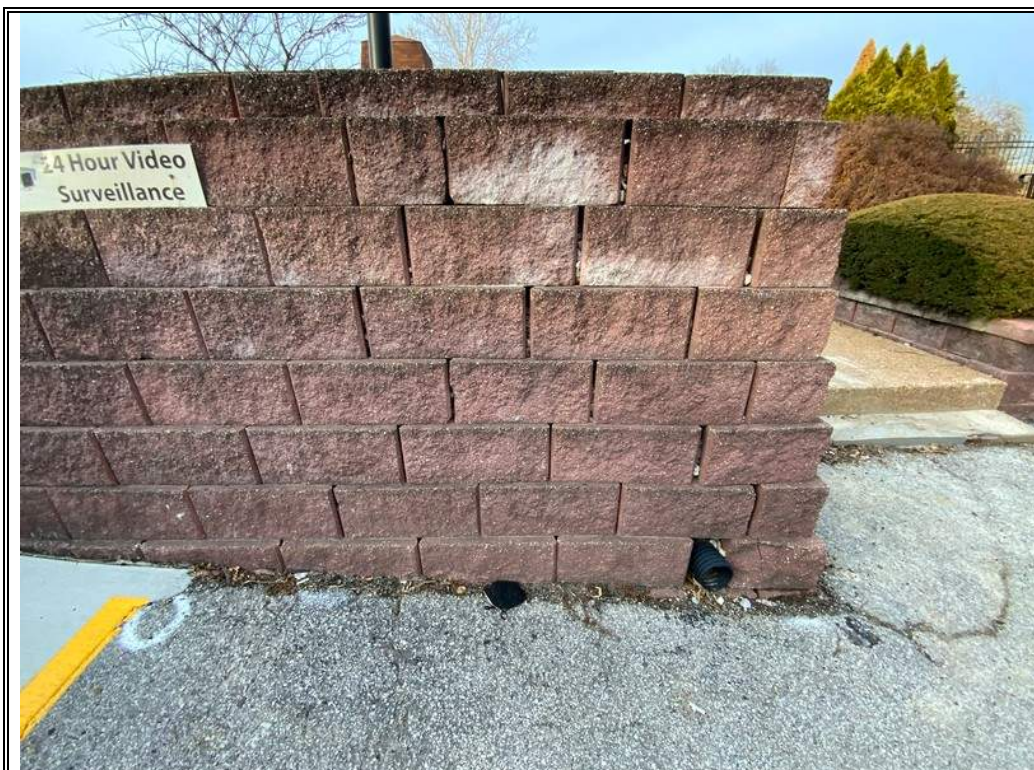
Separation
observed in the
block retaining
walls

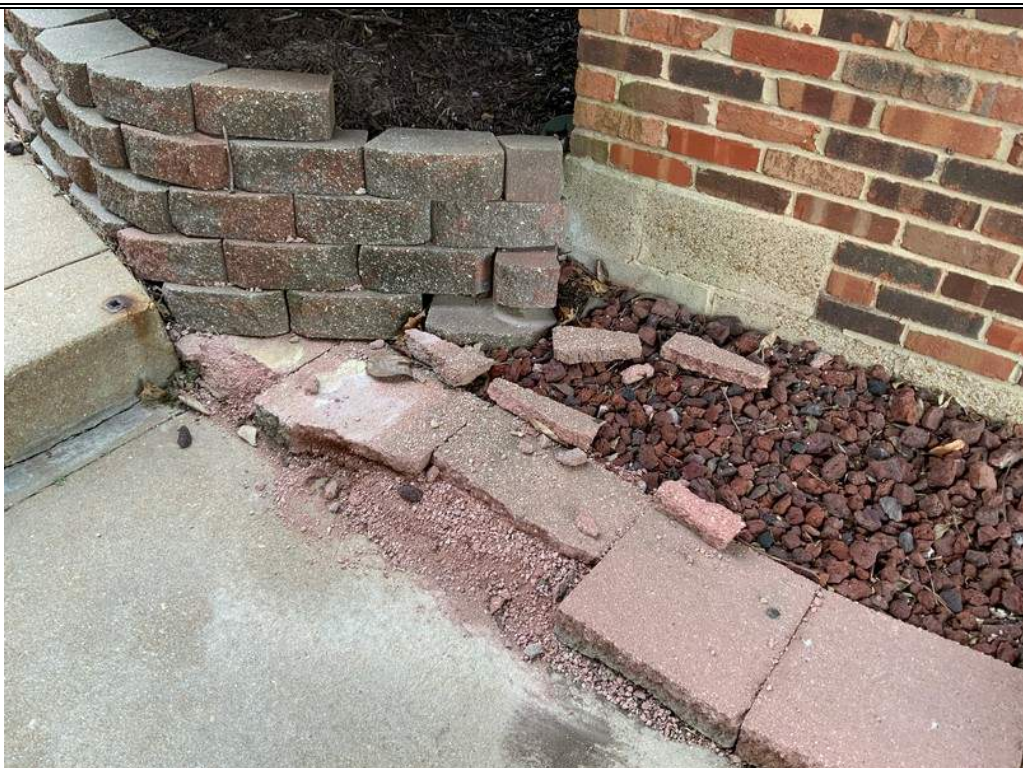
47

Deteriorated
retaining wall
blocks

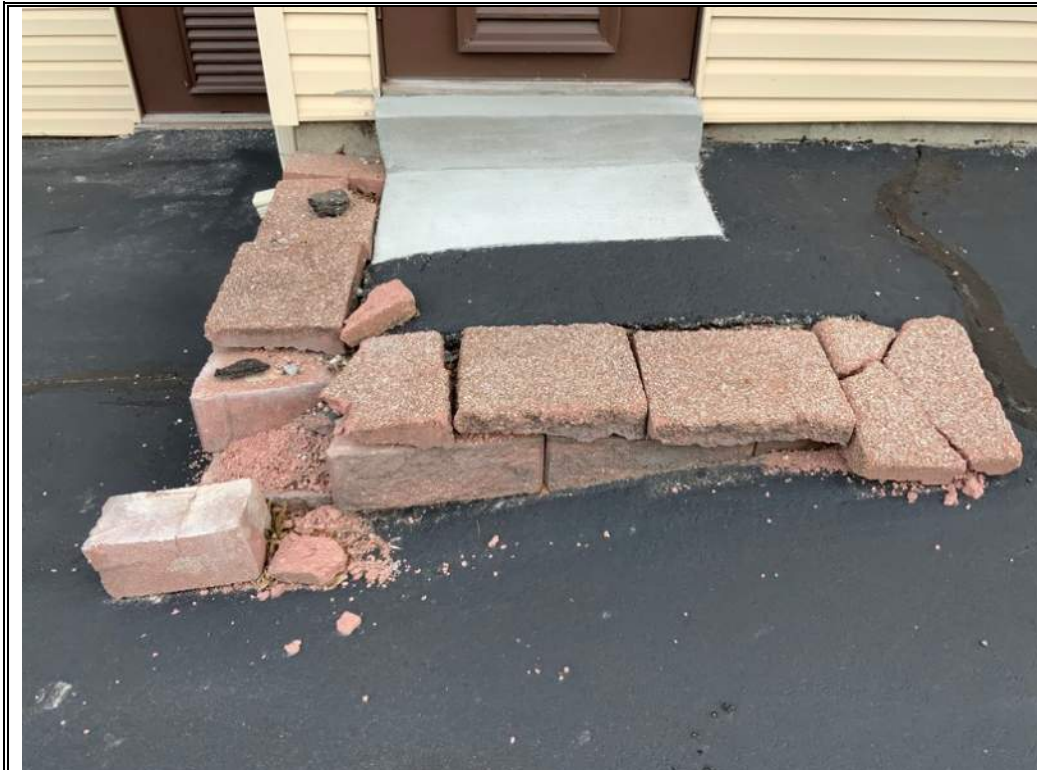
Damaged retaining wall at the rear of the condominium buildings

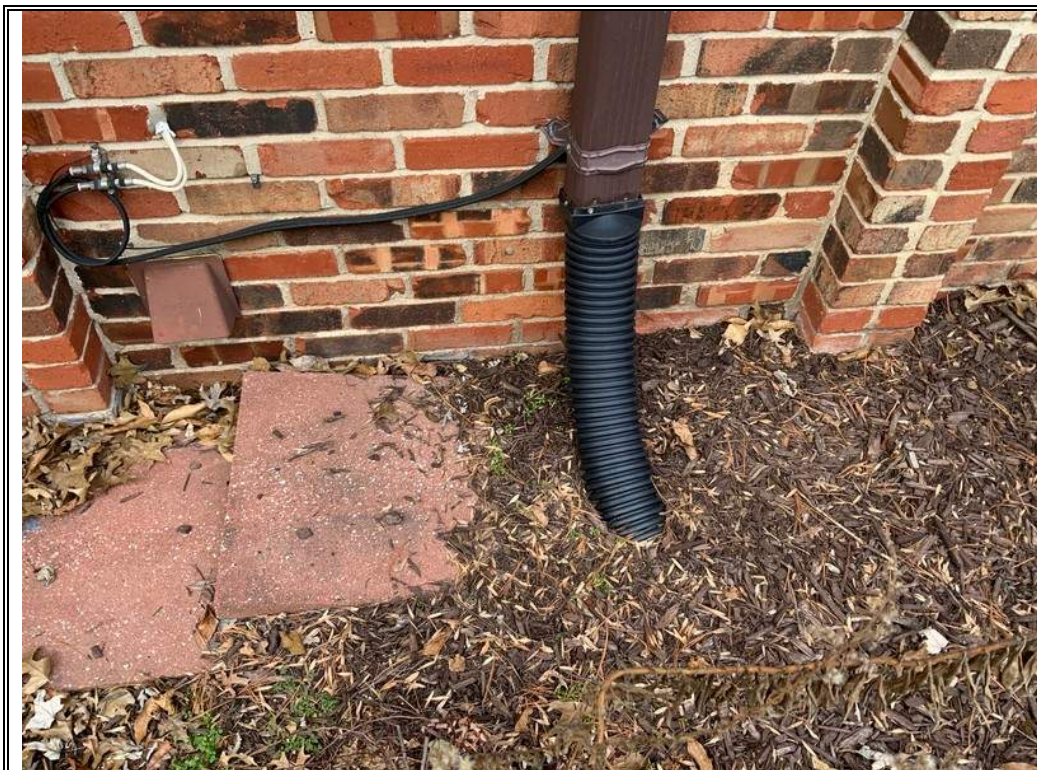
Buried downspout
