Via Email: *MMueller@smithmgmt.com*
Property: **Appletree Condominiums**
1139 Appleseed Ln, Olivette, 63132

Service: **FULL RESERVE STUDY**

Project No.: 202212-10

Appletree Condominium Association Reserve Study

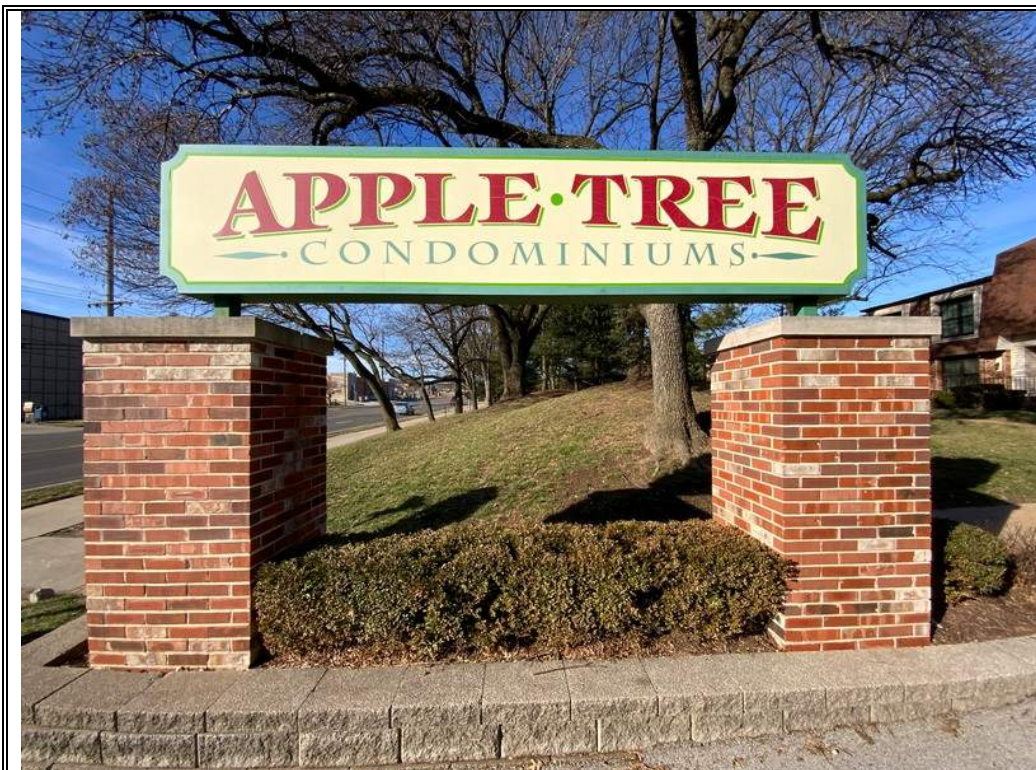
Entrance
monument

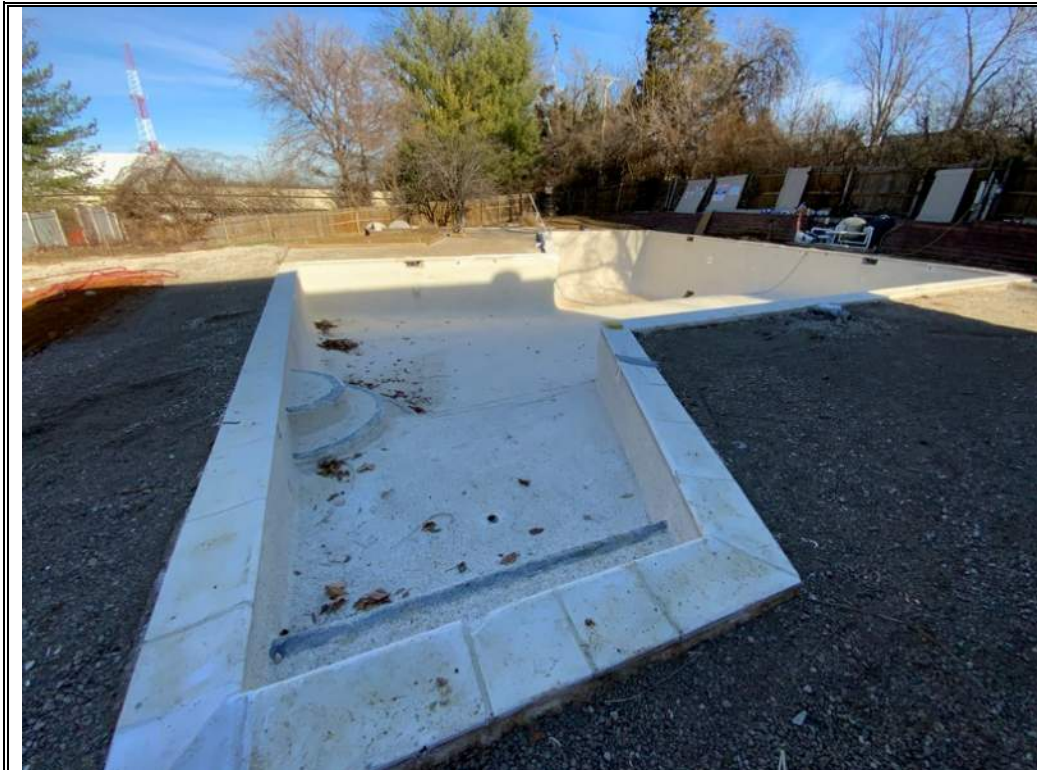
Outdoor pool

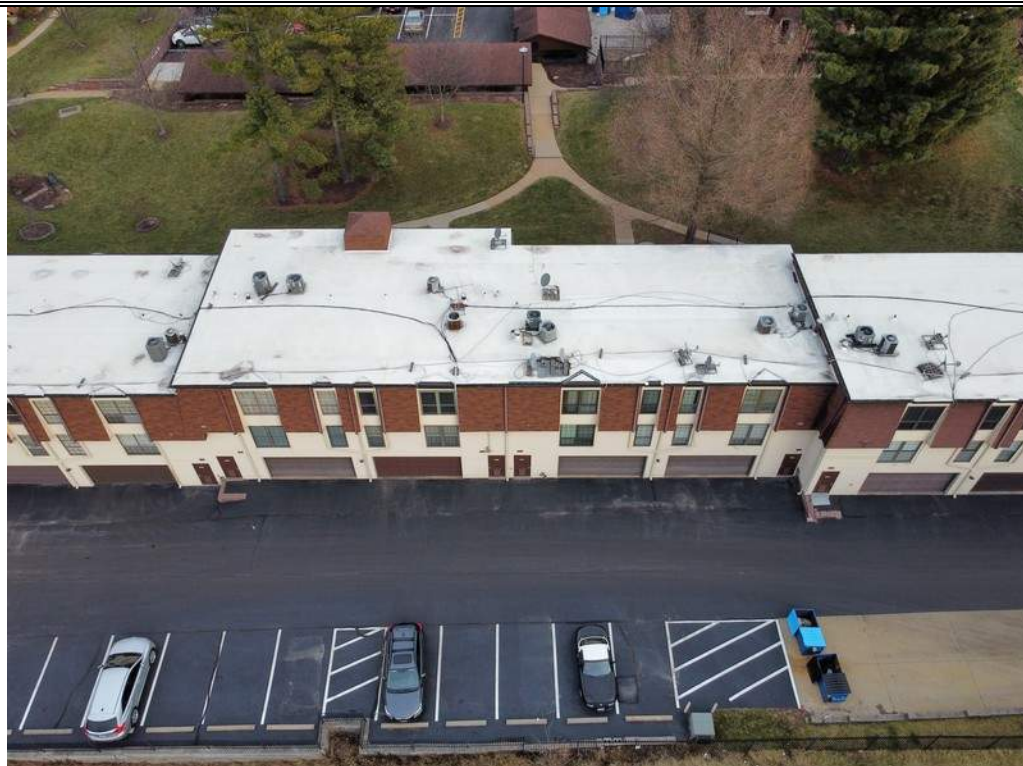
View of the TPO
roofs from the rear
elevation

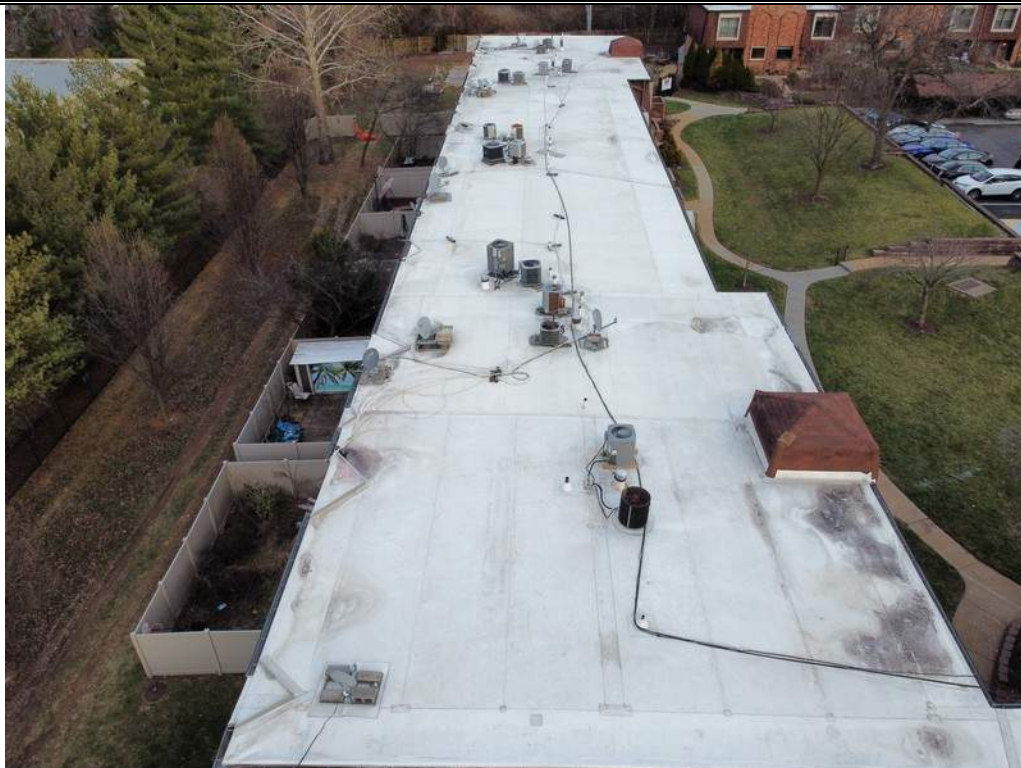
View of TPO
roofs

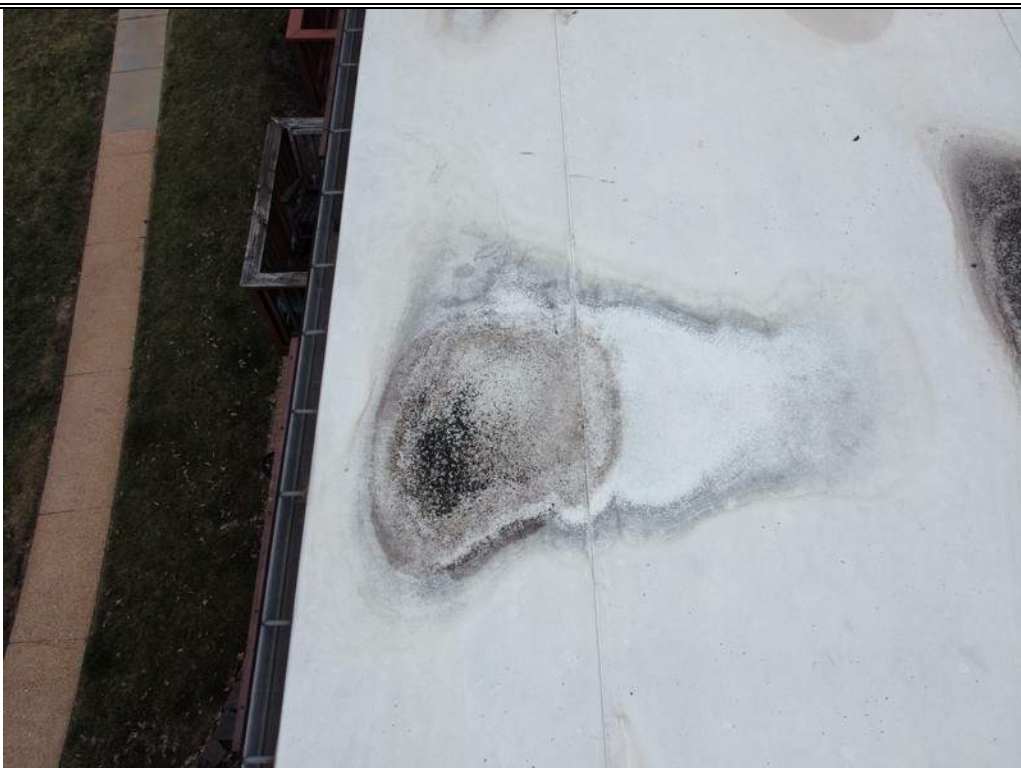
Evidence of
standing water

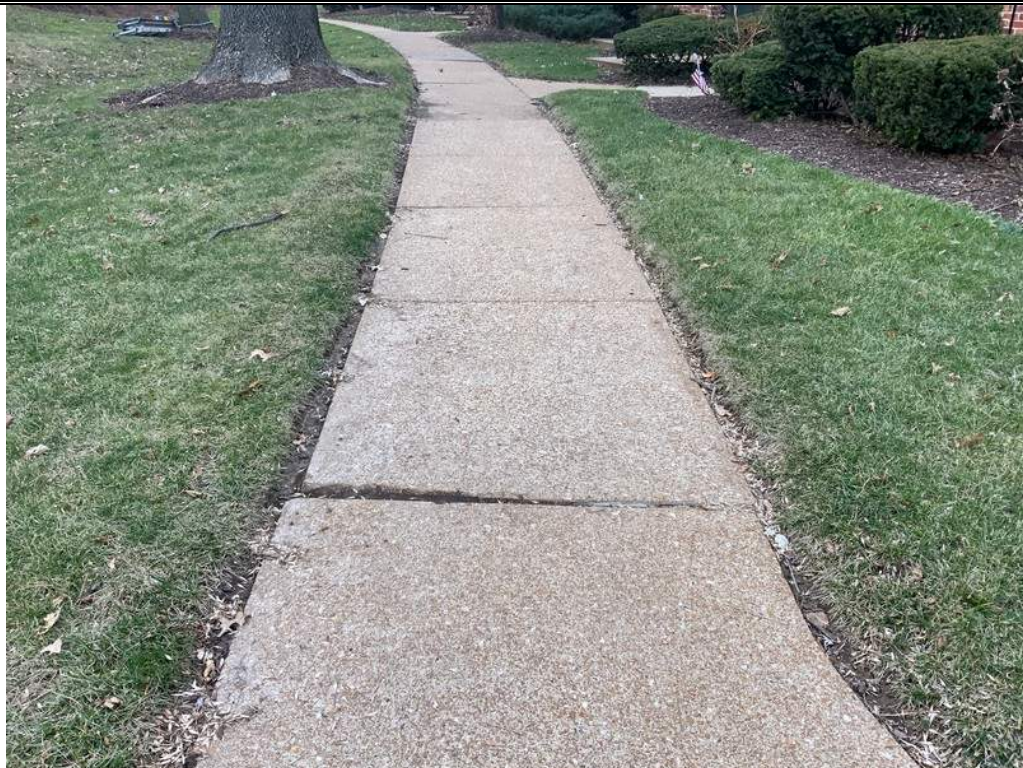
Sidewalk upheaval

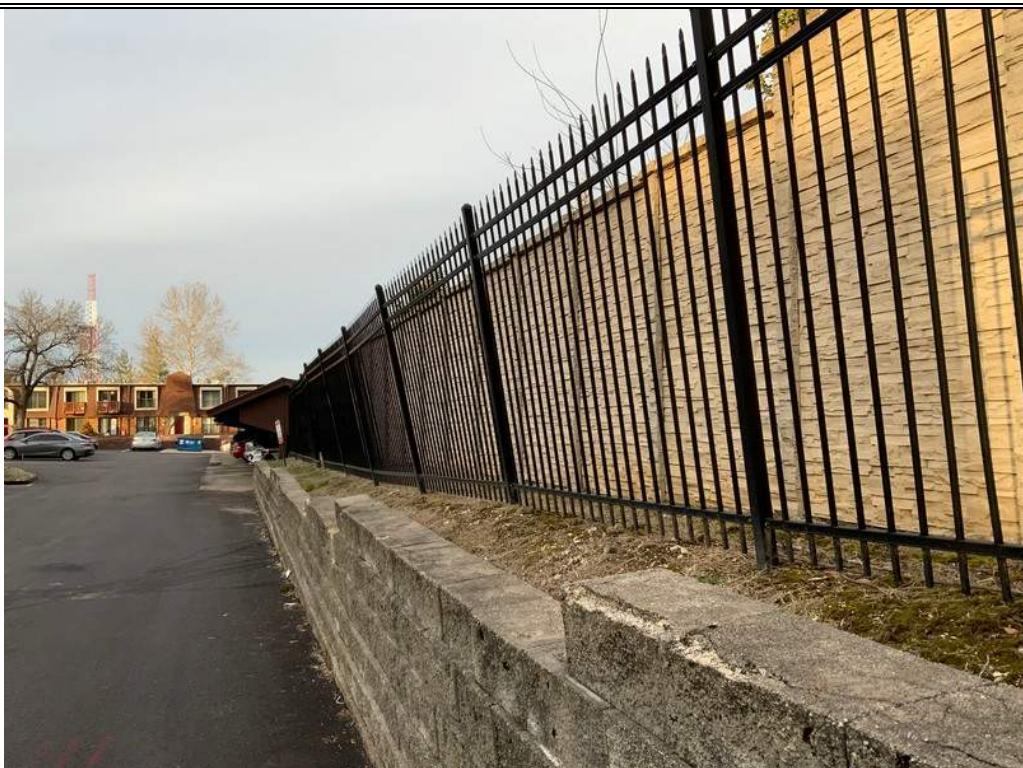
Leaning fencing

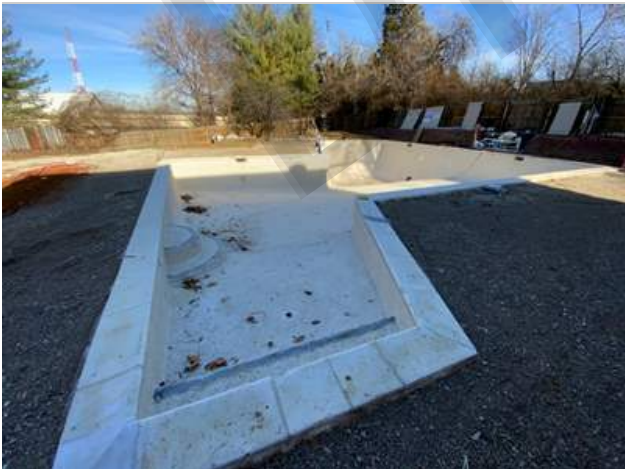
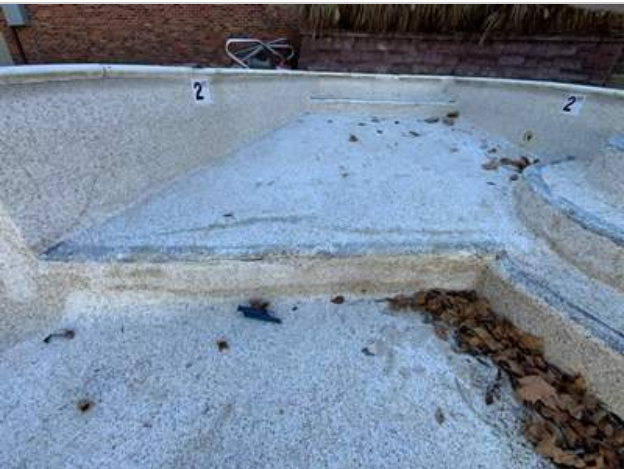
Type of Cost:	Amenities
Location:	Fair
Condition:

unknown when last resurfaces; cracking observed in Pebble Tec surfacing

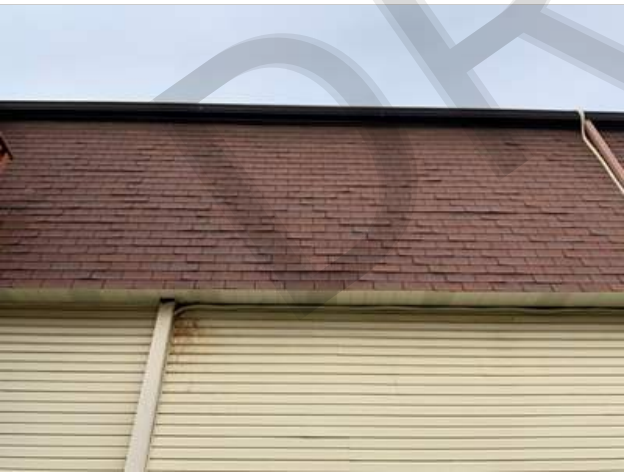
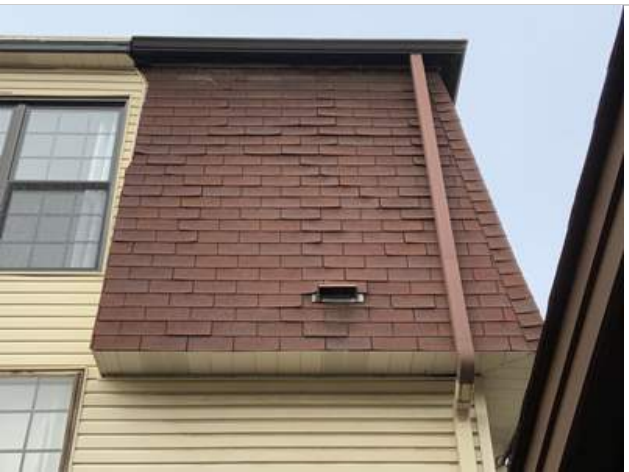
5 - Replace shingles on Mansord roofs and carports

Type of Cost: Building Exterior
Location: Poor
Condition:

poor condition; reported 20+ years old

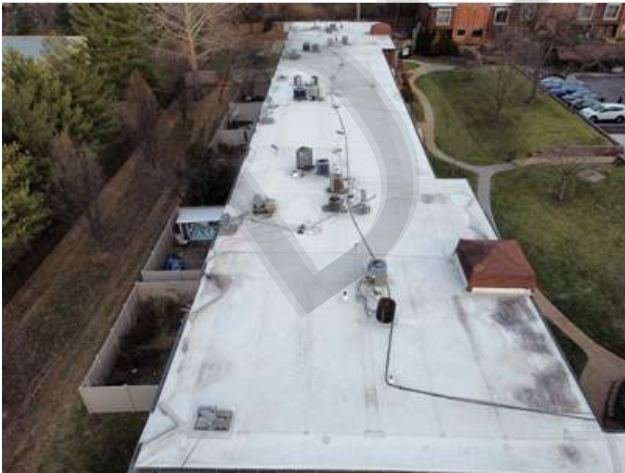
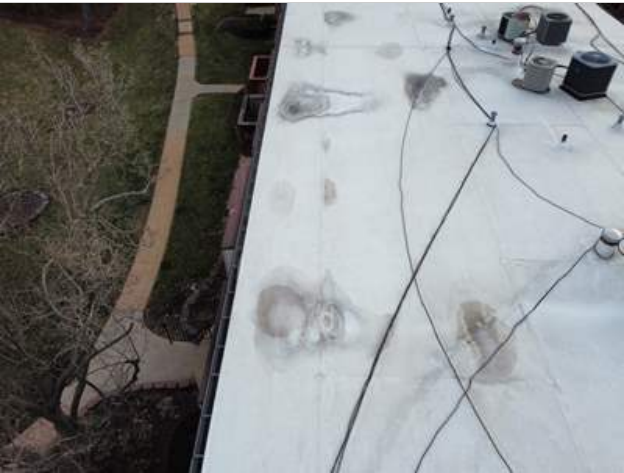
6 - Replace TPO roof membranes

Type of Cost: Building Exterior
Location: Good
Condition:

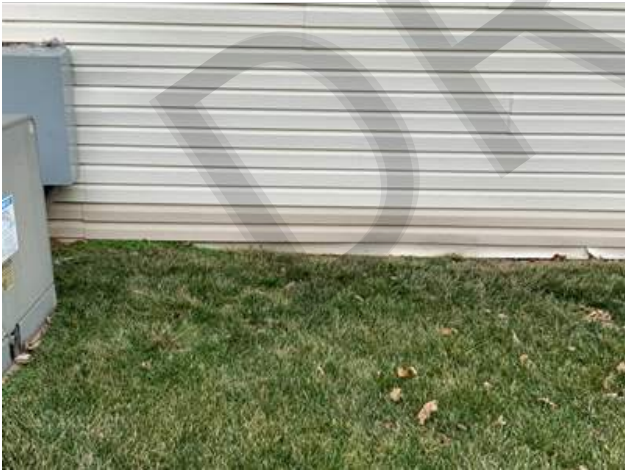
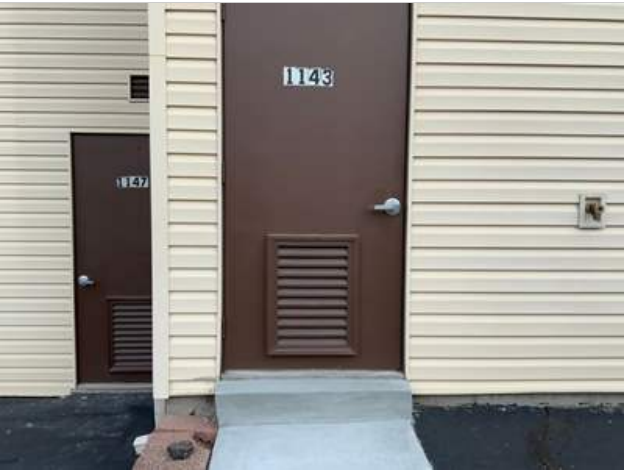
7 - Replace vinyl siding - phase I

Type of Cost: Building Exterior
Location: Fair
Condition:

replaced in 1997

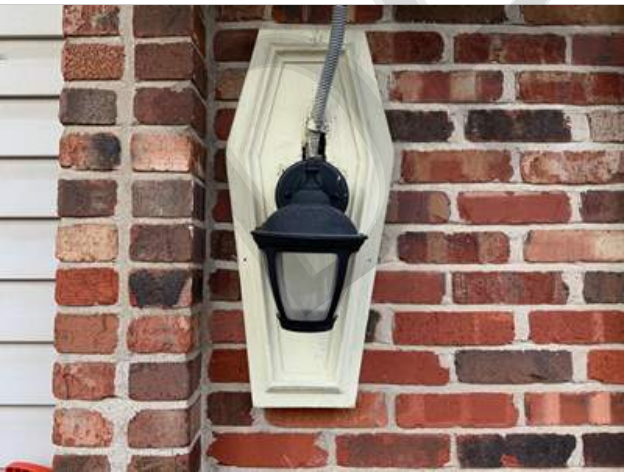
11 - Replace exterior light fixtures

Type of Cost: Building Exterior
Location: Fair
Condition:

mounted light fixtures at building entrances

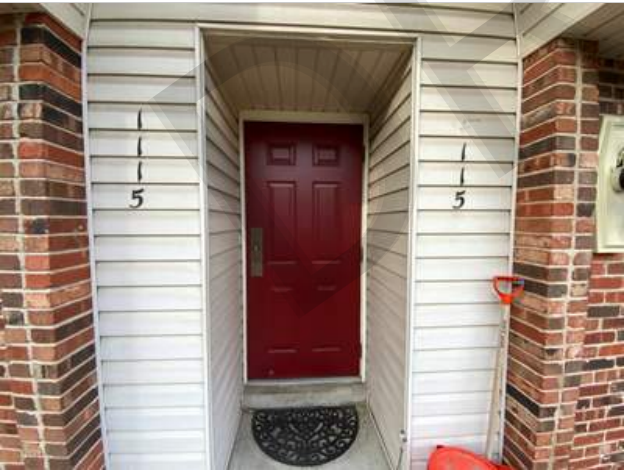
12 - Replace entry doors

Type of Cost: Building Exterior
Location: Good
Condition:

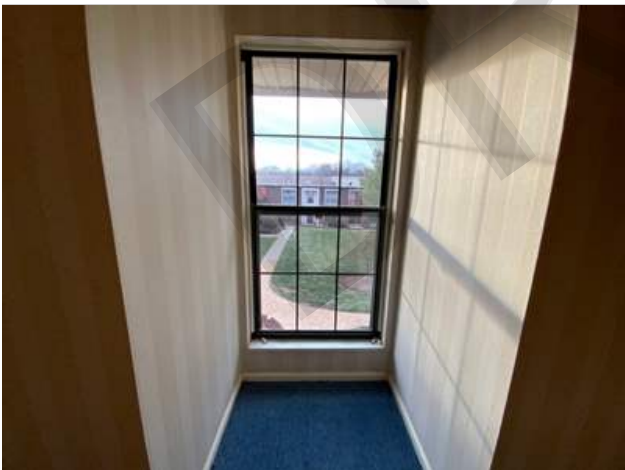
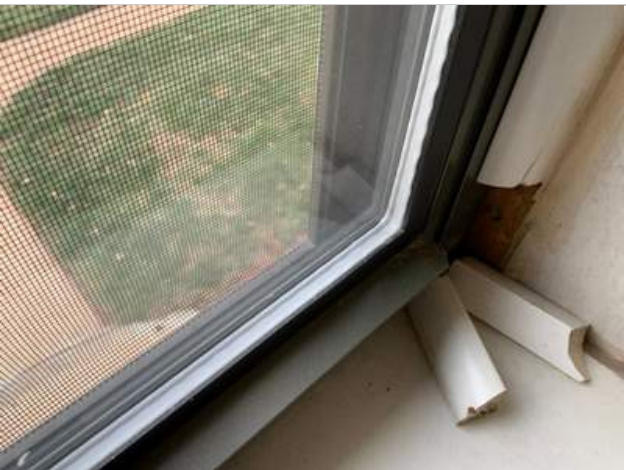
13 - Replace common stairwell windows

Type of Cost:	Building Exterior
Location:	Good
Condition:

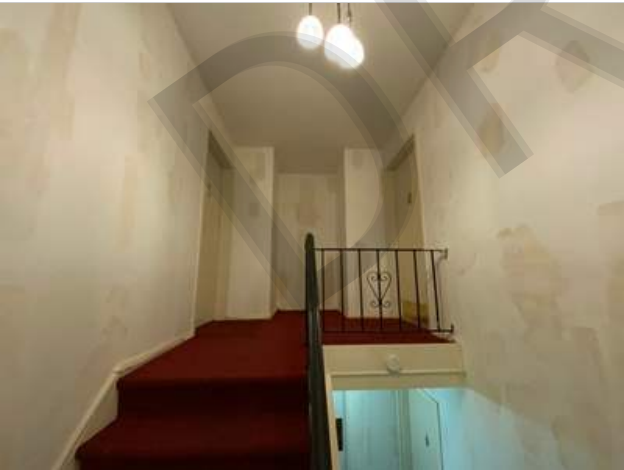
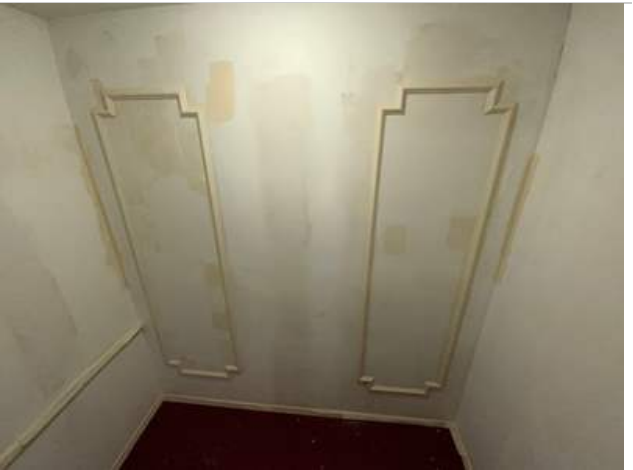
14 - Paint common stairwells

Type of Cost: Building Interior
Location: Poor
Condition:

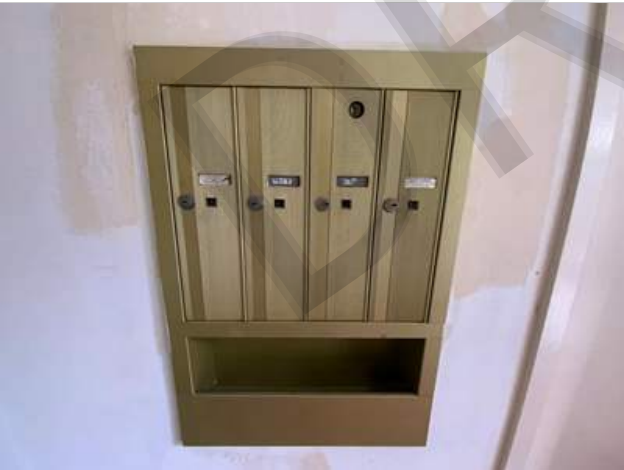
16 - Replace mailbox inserts

Type of Cost:	Building Interior
Location:	Fair
Condition:

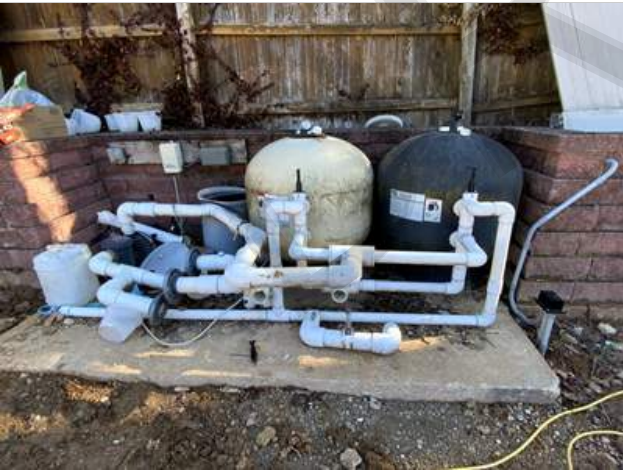
17 - Replace pool pumps and filters

Type of Cost:	Mechanical
Location:	Fair
Condition:

unknown when last replaced; two Triton II sand filters and one 3.0 HP Century pump

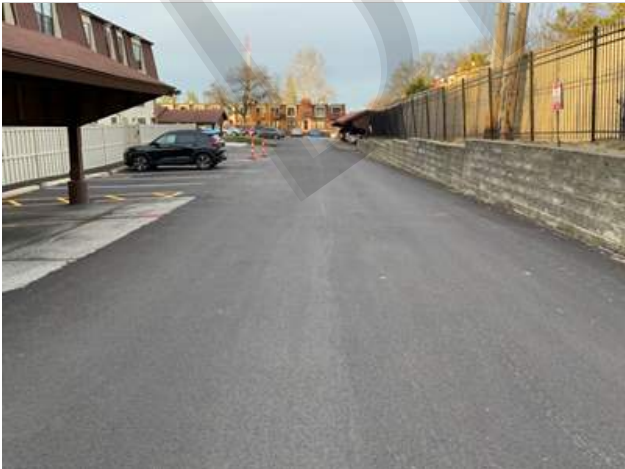
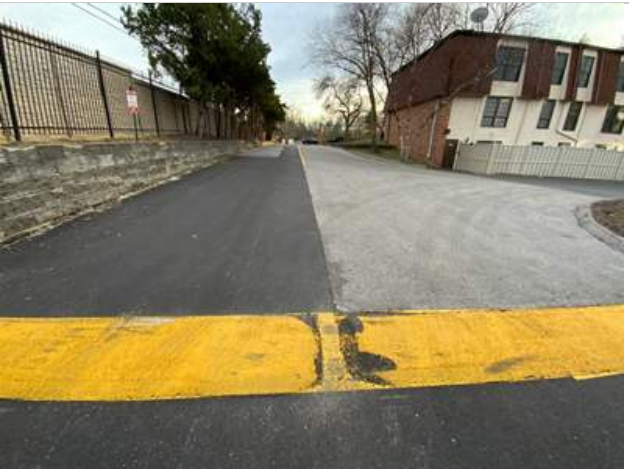
21 - Full depth repairs of sections of streets and parking areas

Type of Cost:	Repairs & Maintenance
Location:	Site
Condition:	Good

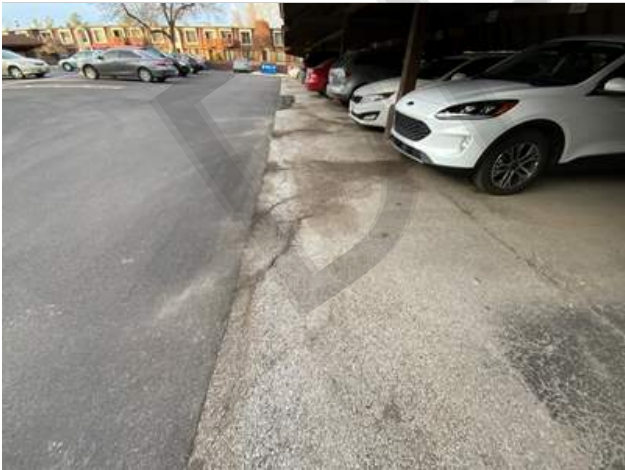
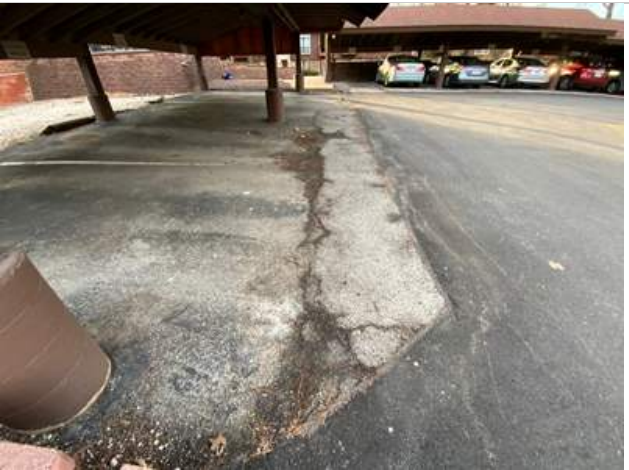
Type of Cost:	Site
Location:	Fair
Condition:

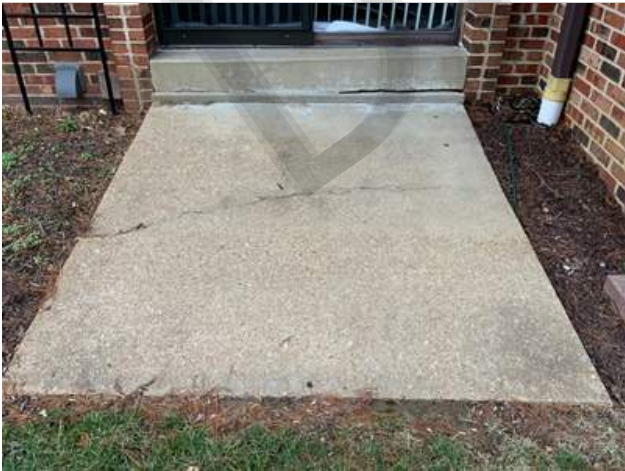
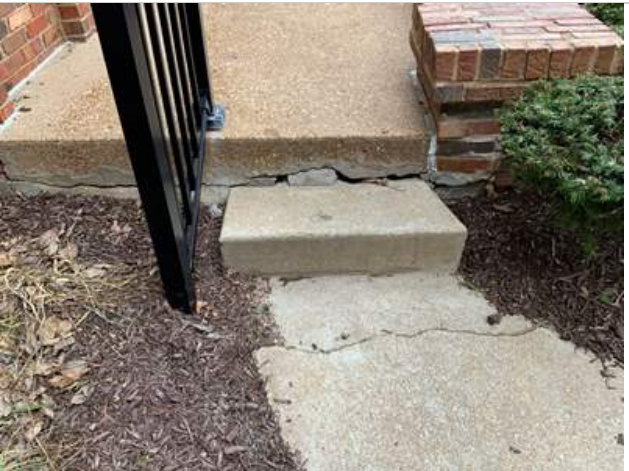
26 - Sectional repairs to concrete surfaces

Type of Cost: Site
Location: Fair
Condition:

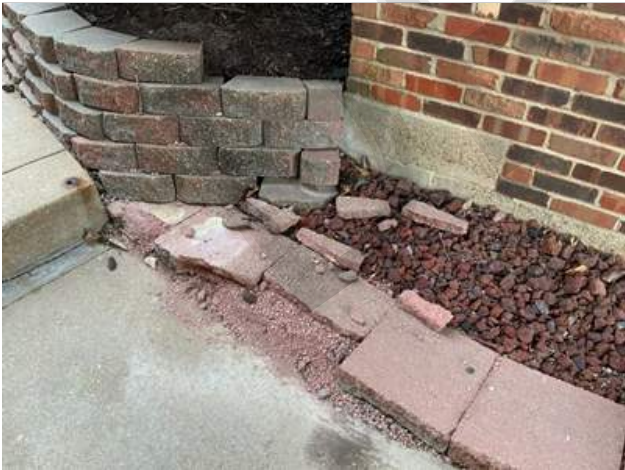
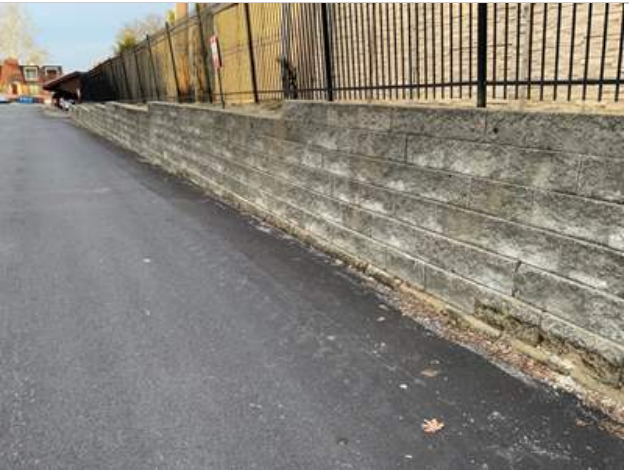
27 - Allocation for major retaining wall repairs/replacement

Type of Cost:	Site
Location:	Good
Condition:

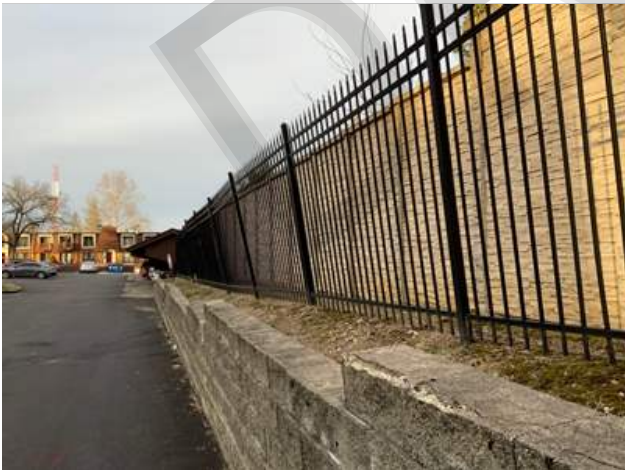
28 - Replace metal fencing above retaining walls and around pool

Type of Cost:	Site
Location:	Good
Condition:

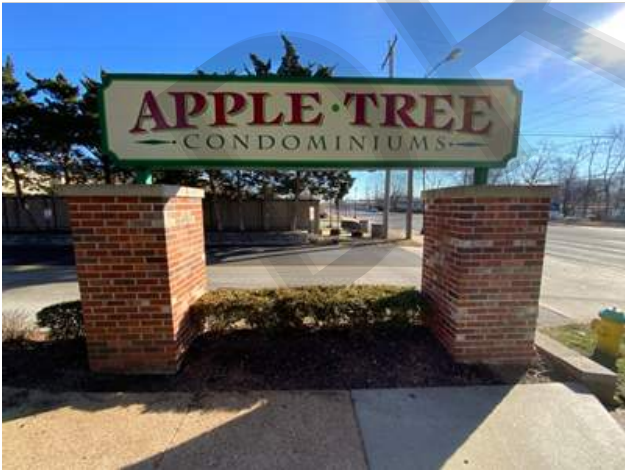
29 - Replace/refurbish entrance monument

Type of Cost:	Site
Location:	Fair
Condition:

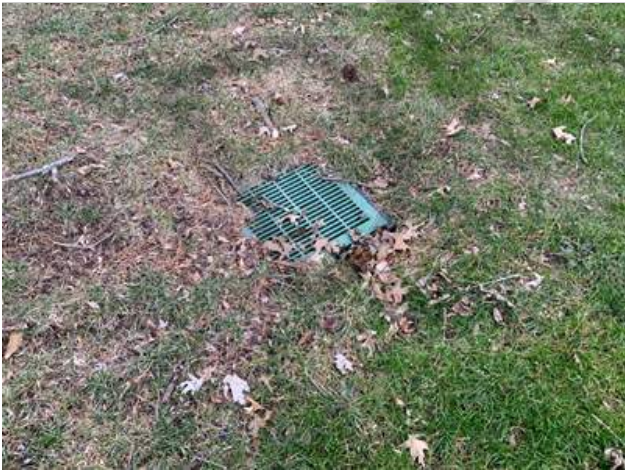
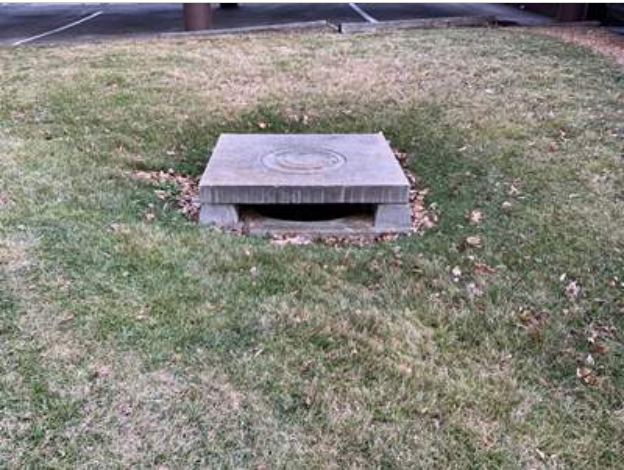
30 - Common area drainage improvements

Type of Cost:	Site
Location:	Good
Condition:
